3.0 FACILITY DESCRIPTION

WVDP PHASE 1 DECOMMISSIONING PLAN

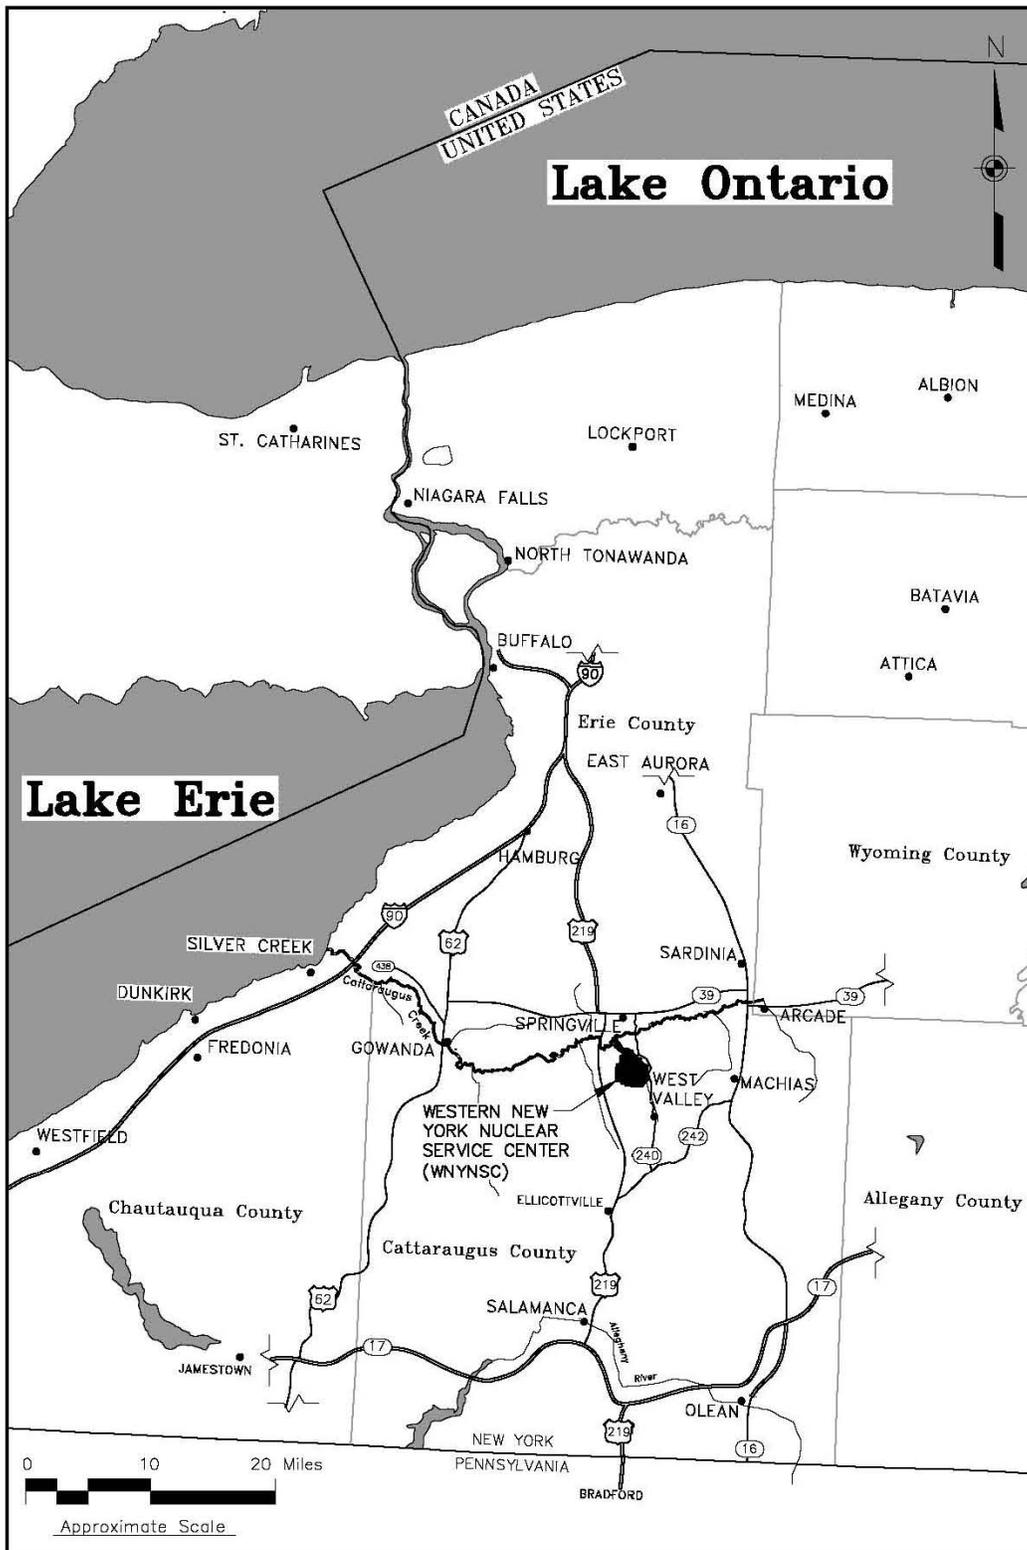
Figure 3-1. Location of the Center in Western New York

The WVDP is located about 30 miles south of Buffalo, in the Town of Ashford, Cattaraugus County, New York at approximately 42.45° north latitude and 78.646° west longitude. The site location with respect to major natural and man-made features in the region is shown in Figure 3-1.

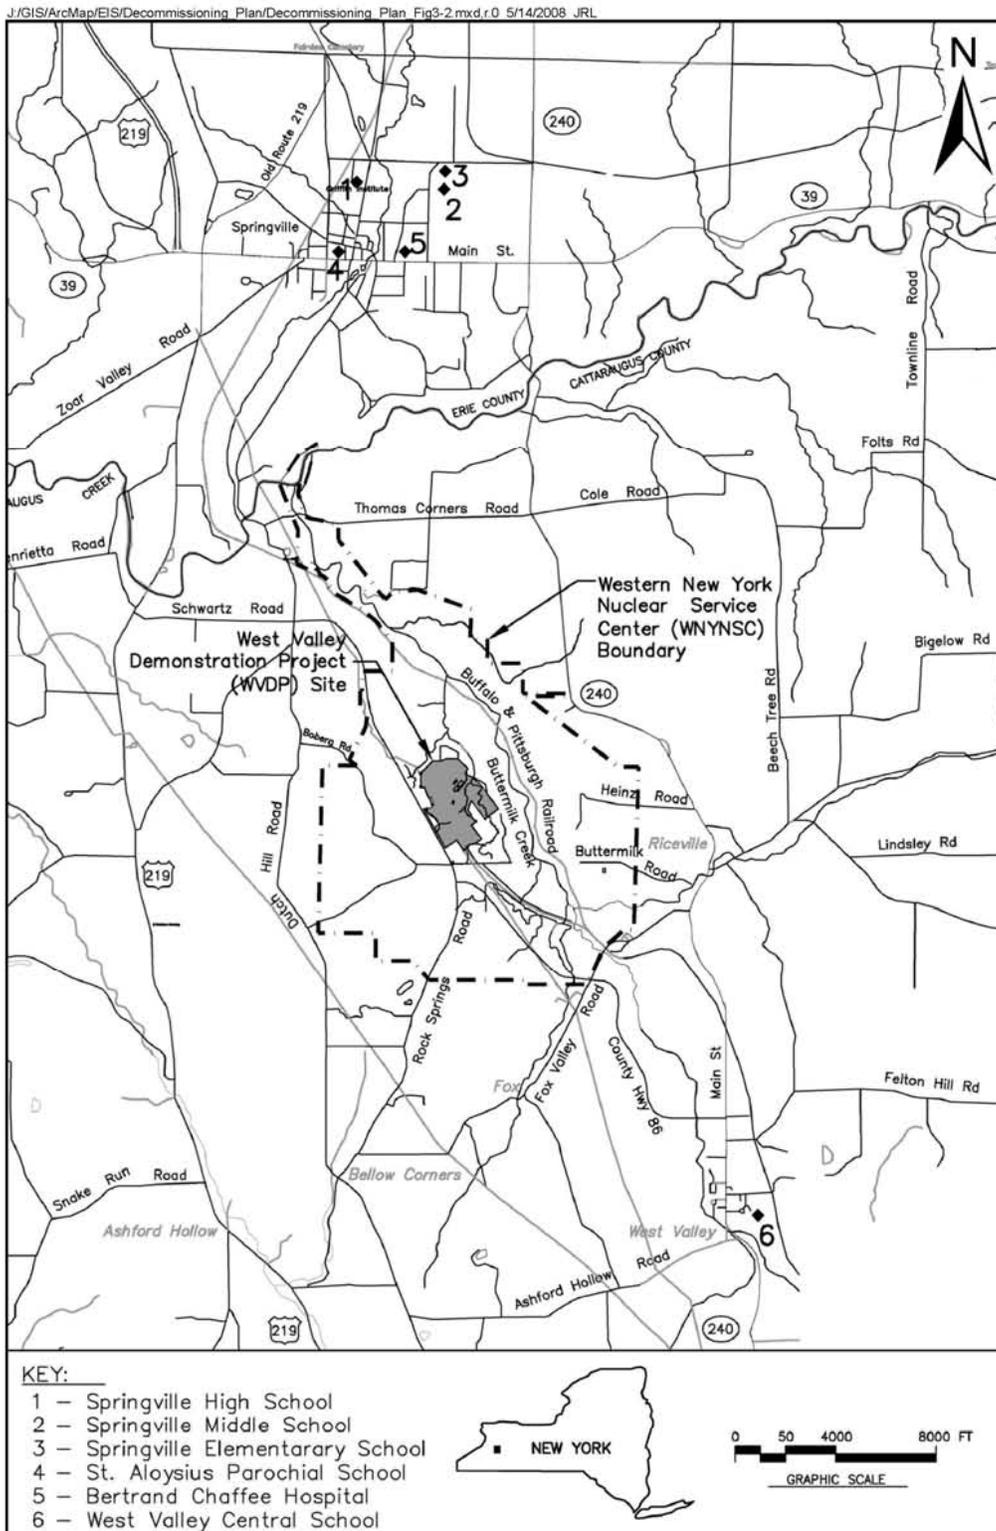
Figure 3-2. The Center, the WVDP, and the Surrounding Area

The WVDP site consists of approximately 167 acres within the 3,345-acre Center. Figure 3-2 delineates the boundaries of the Center and the WVDP. The brief description here focuses on the Center, the WVDP, subsurface conditions on the site, and site groundwater.

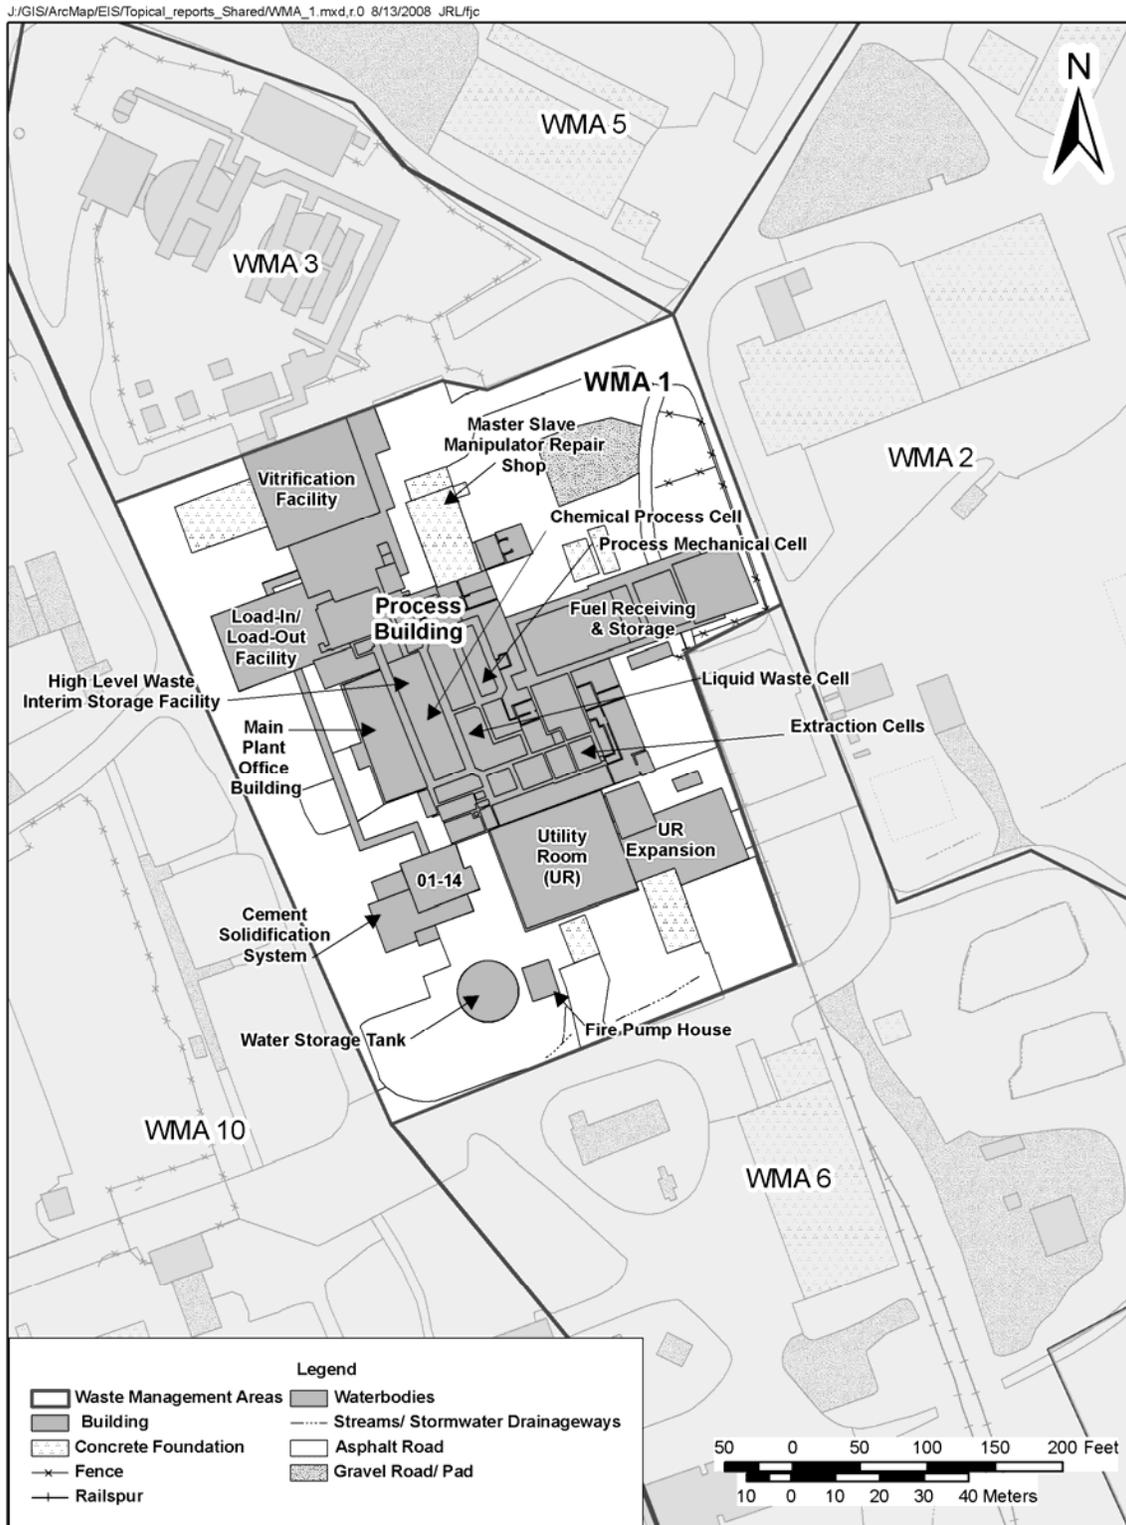
Figure 3-10. WMA 1. (The Phase 1 proposed decommissioning activities would include removal of the facilities and the underlying north plateau groundwater plume source area.)

Fire Pump House and Water Storage Tank. The Fire Pump House was constructed in 1963 and is 20 feet wide, 24 feet long, and 10 feet high at the peak. The structure is of steel frame and sheet metal construction on a four-inch concrete slab floor, which is supported on a concrete foundation wall. Its location is shown in Figure 3-10.

Electrical Substation. The electrical substation is located adjacent to the southeast corner of the Process Building. A 34.5 kilovolt/480 volt transformer rests on a concrete foundation behind a steel framed structure. Its location is shown in Figure 3-10.

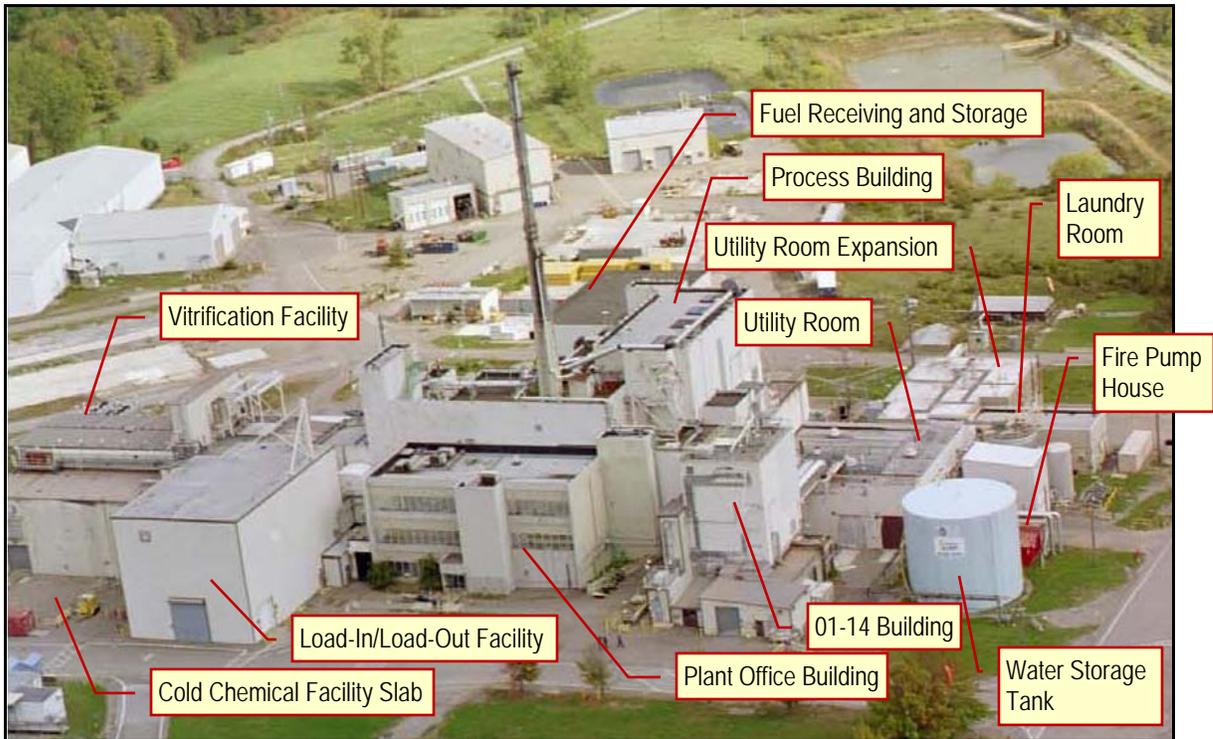
Figure 3-11. Aerial View of the Process Building Area and Vitrification Facility Area in 2007.
(The Laundry Room will be removed before the Phase 1 decommissioning begins.)

The Pump House contains two pumps on concrete foundations. An adjacent small metal storage shed is used to store fire hoses and fire extinguishers. The 475,800-gallon water storage tank (Tank 32D-1) is located outside the Utility Room, as shown in Figure 3-11.

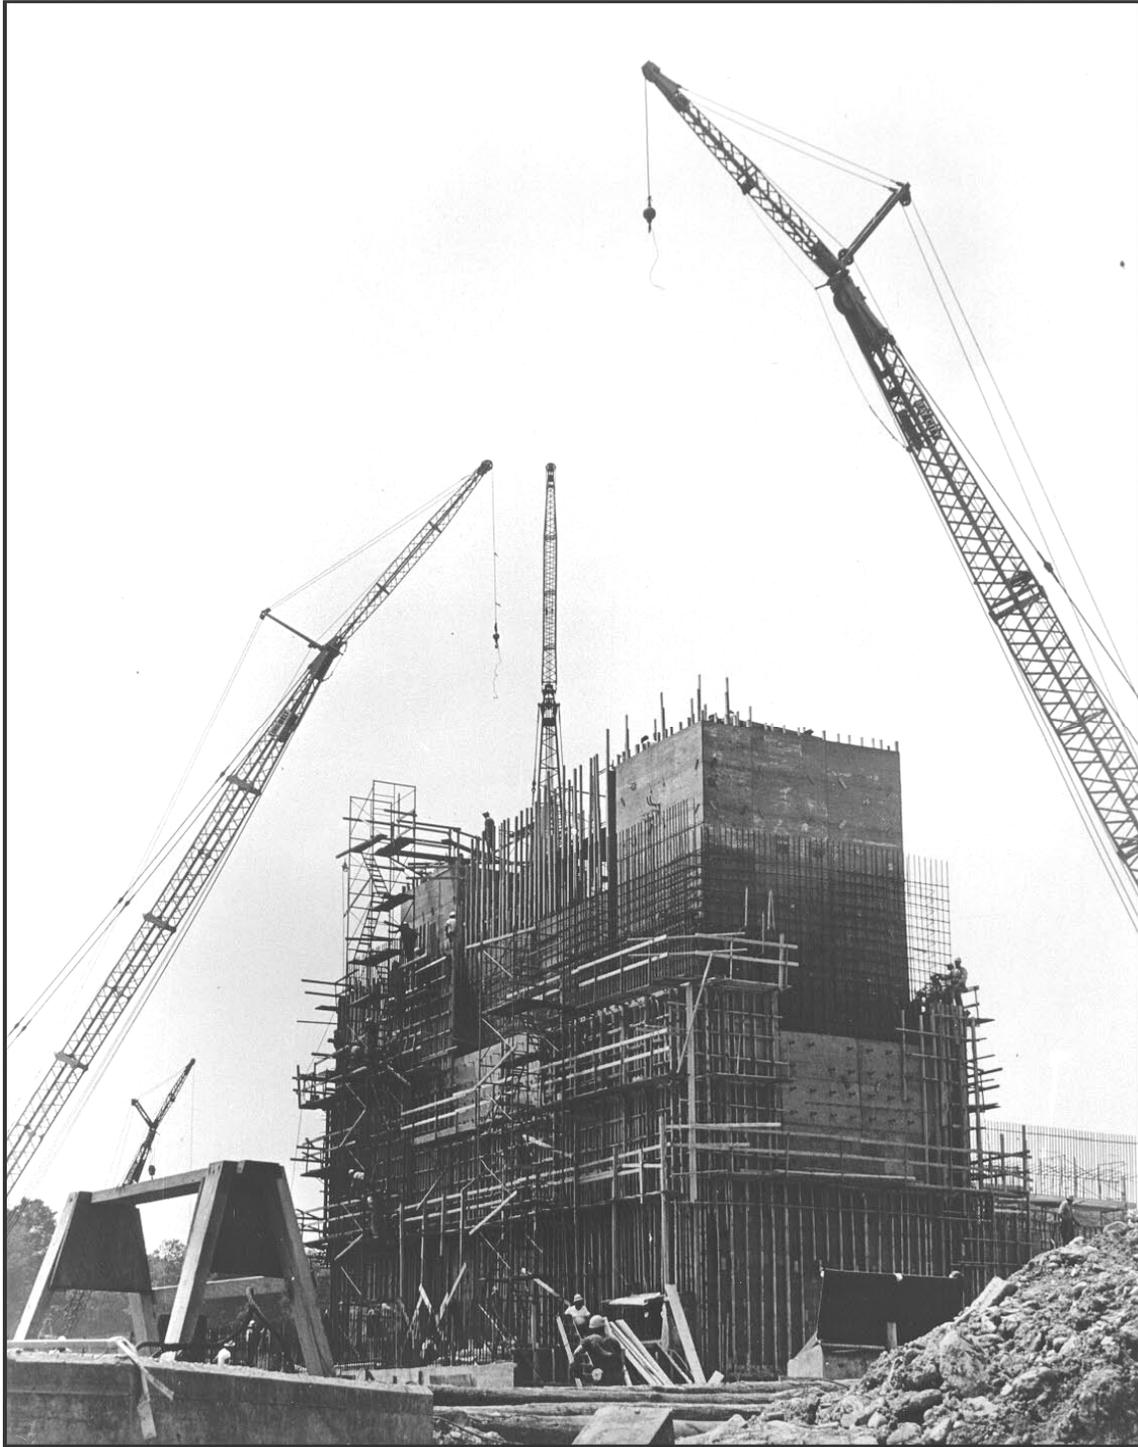
Figure 3-12. Construction of the Process Building.

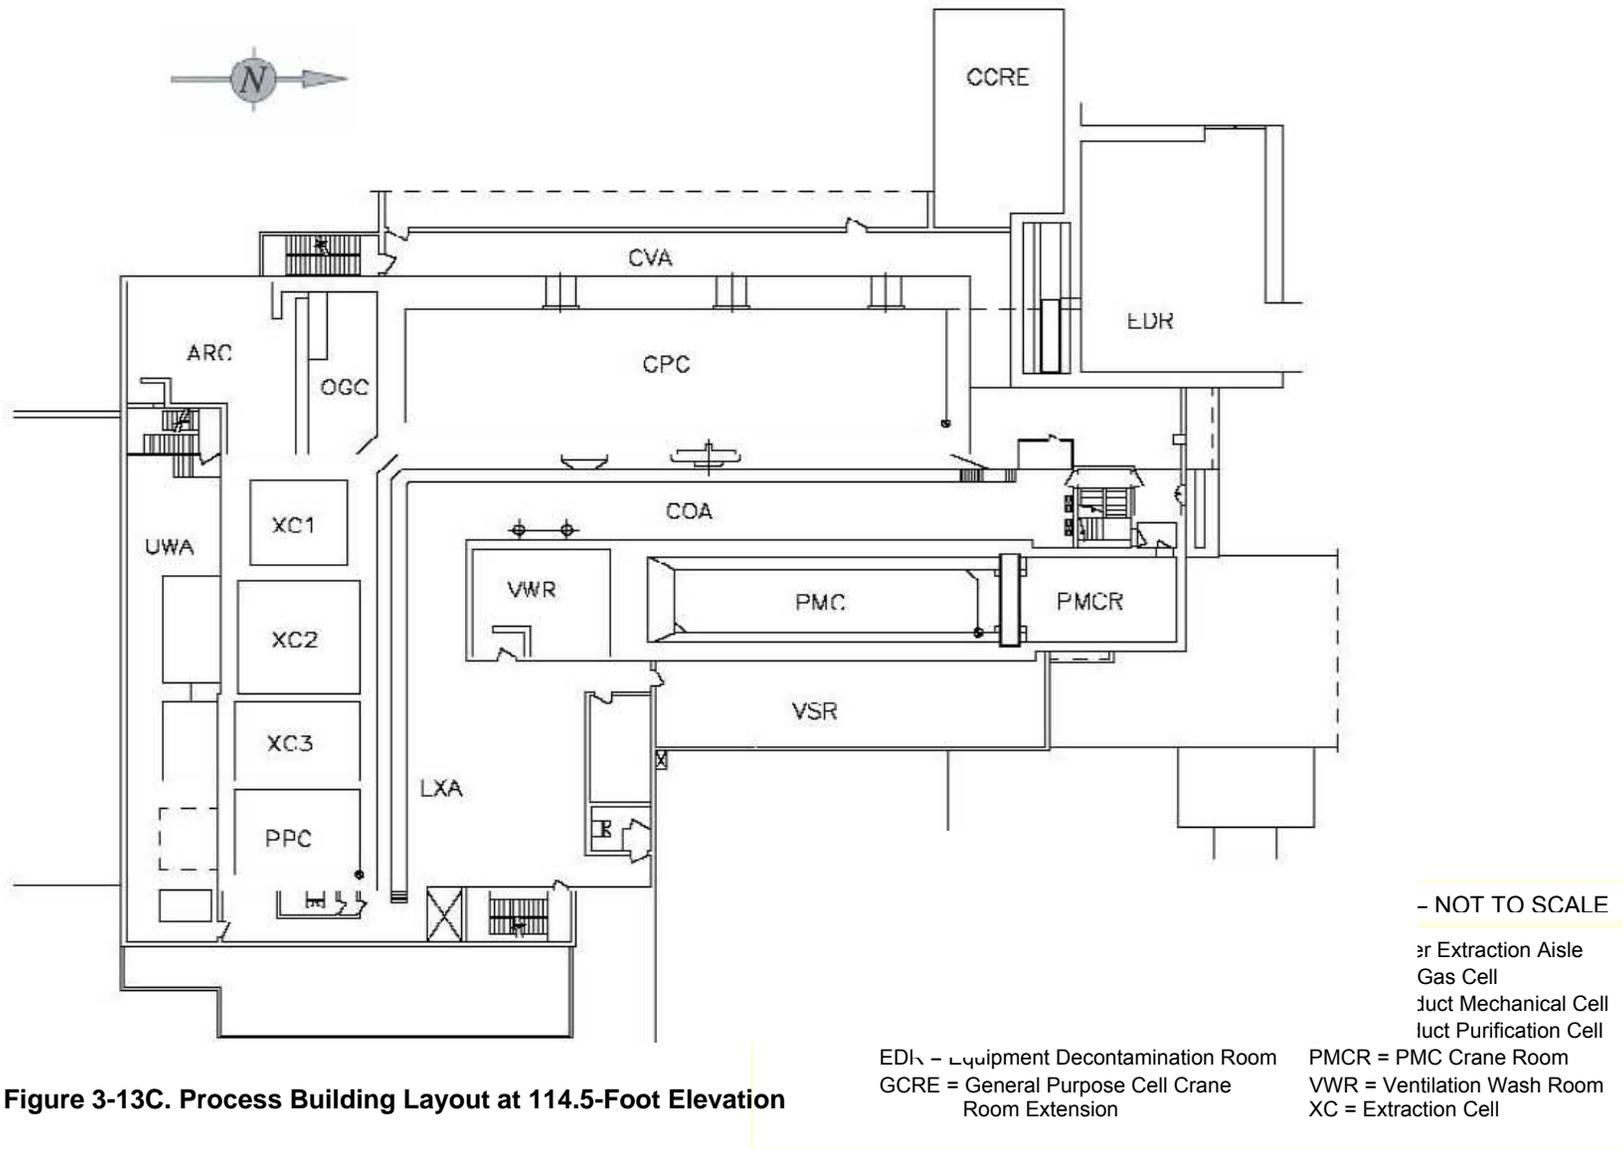
Figure 3-13C. Process Building Layout at 114.5-Foot Elevation

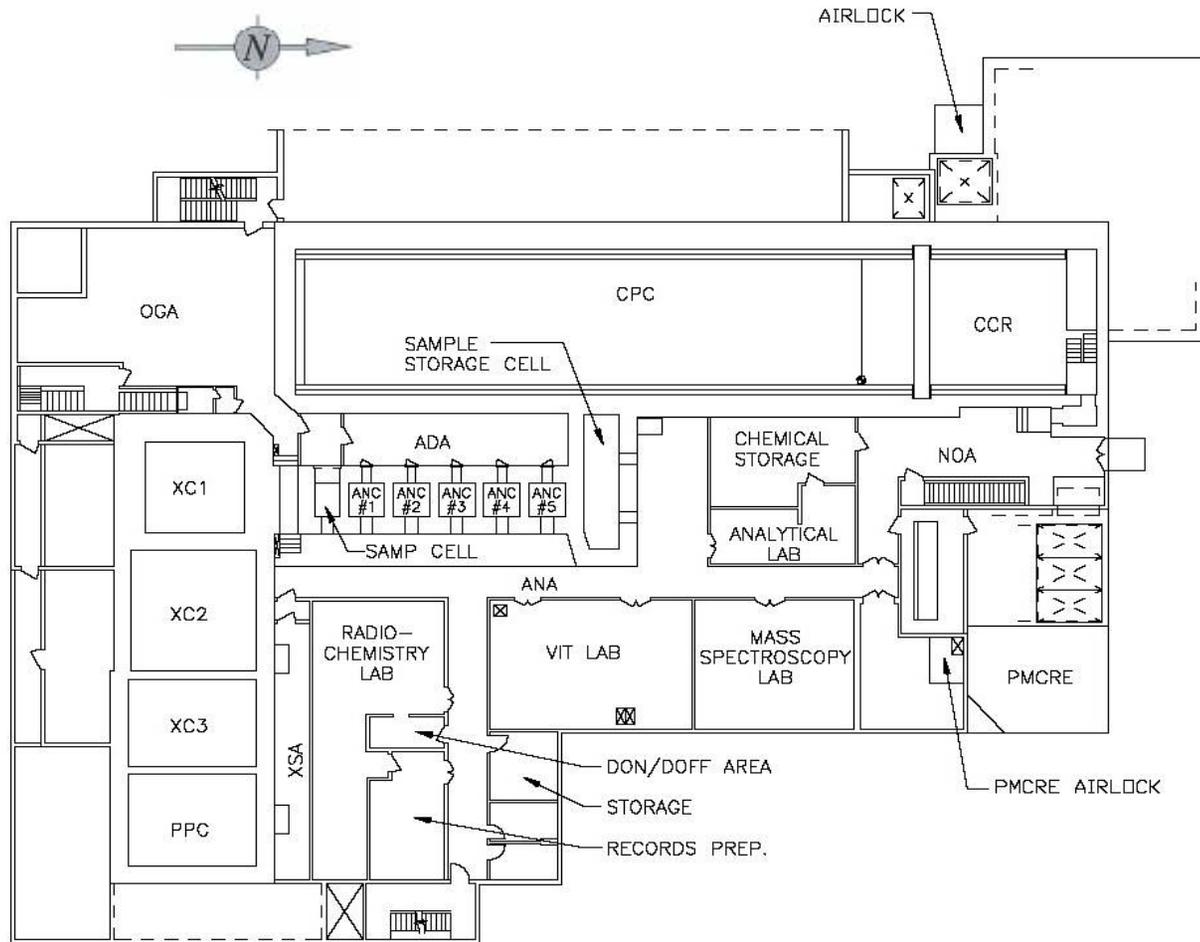
Figure 3-13D. Process Building Layout at 131-Foot Elevation

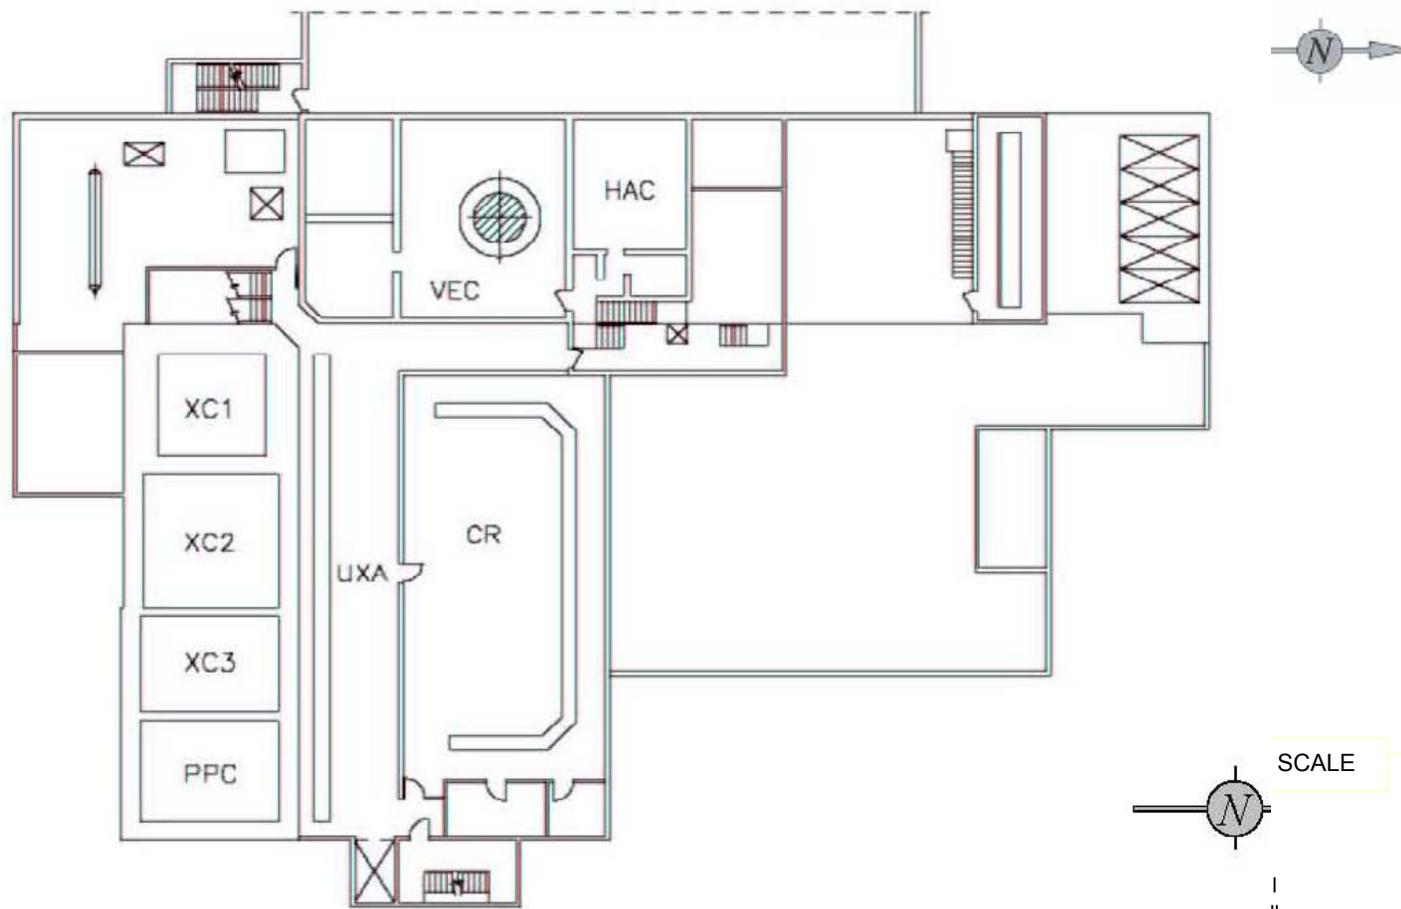
Figure 3-13E. Process Building Layout at 144-Foot Elevation

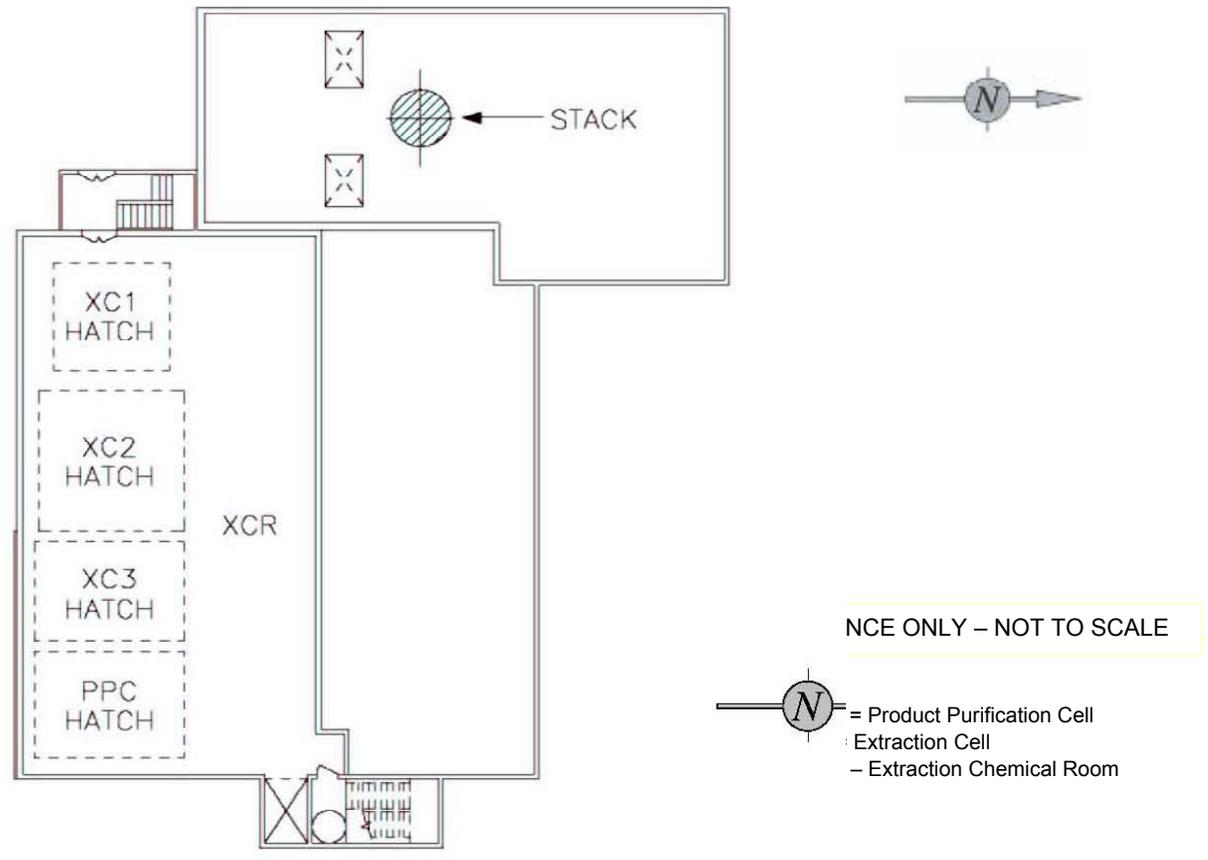
Figure 3-13F. Process Building Layout at 160-Foot Elevation

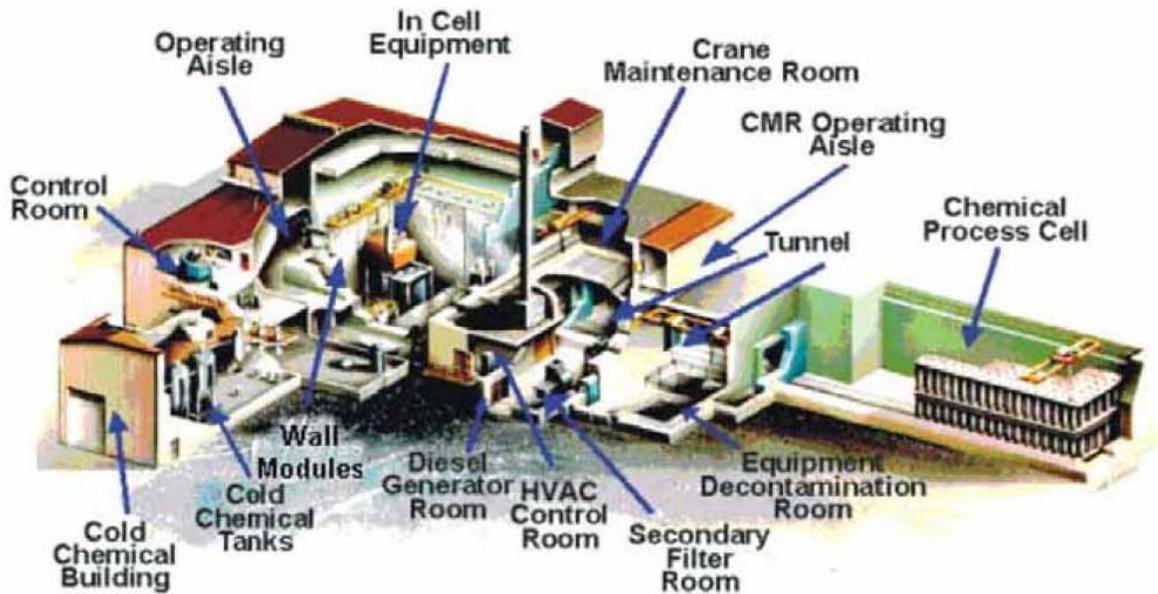
Figure 3-22. Vitrification Facility General Arrangement

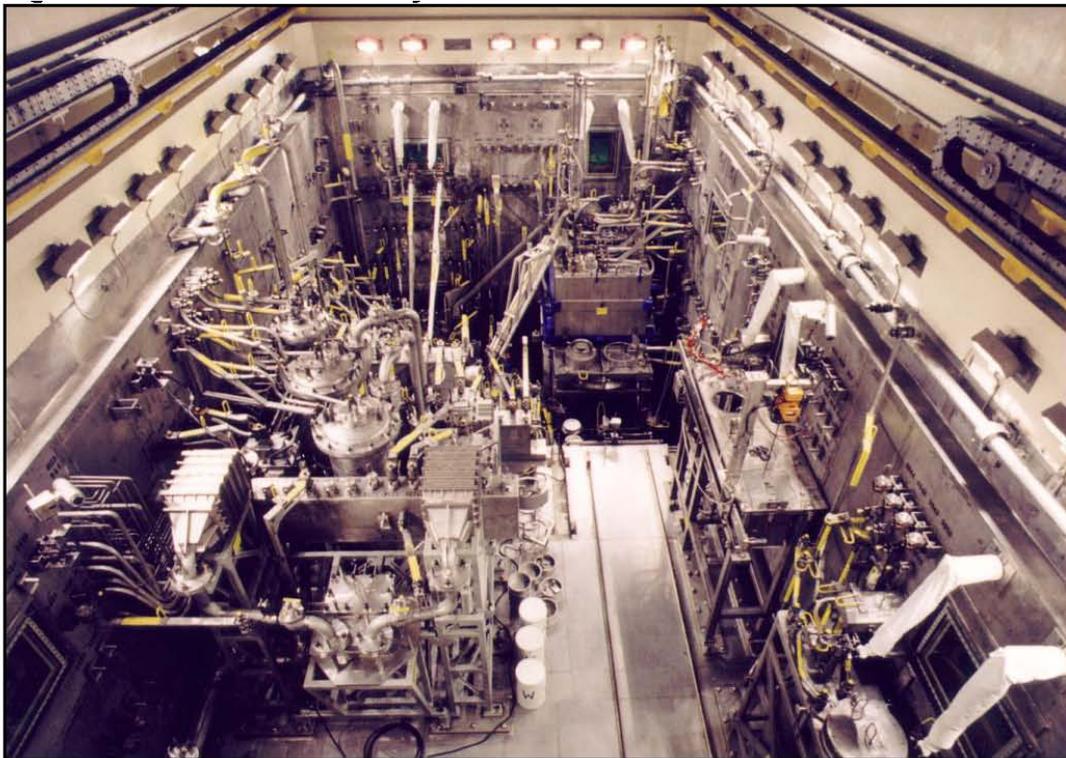
Figure 3-23. Vitrification Cell at Time of Startup

At the north end of the Vitrification Cell is the melter pit. The pit is 34 feet wide by 25 feet long with its bottom about 14 feet below grade. The Vitrification Cell is lined with 0.125-inch-thick stainless steel up to 22 feet above grade.

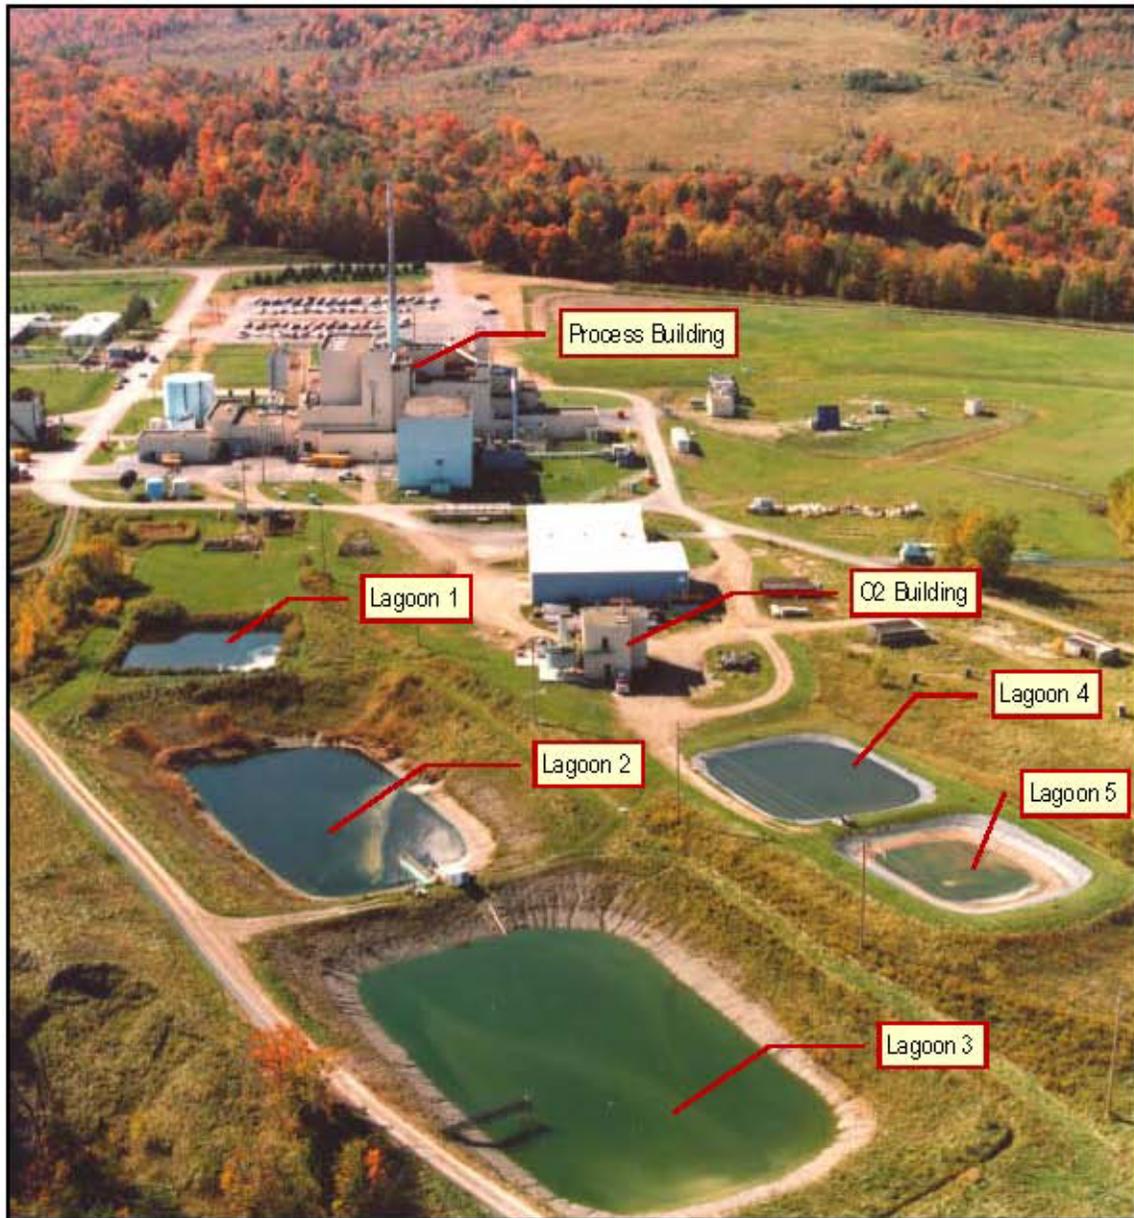
Figure 3-25. The Low-Level Waste Treatment Facility. (This photo shows the site in 1982, looking toward the southwest.)

O2 Building Slab. The O2 Building was a two-story, steel-framed concrete block structure 27 feet wide, 39 feet long, and 30 feet high. It contains a 16 feet deep stainless steel lined sump. Figure 3-25 shows the building when it was in service.

The O2 Building once housed filters, ion exchangers and other equipment used by NFS and the WVDP to treat radioactive wastewater before transfer to Lagoon 3. It was replaced with the LLW2 Building. It was demolished down to its concrete floor slab at grade in October 2006.

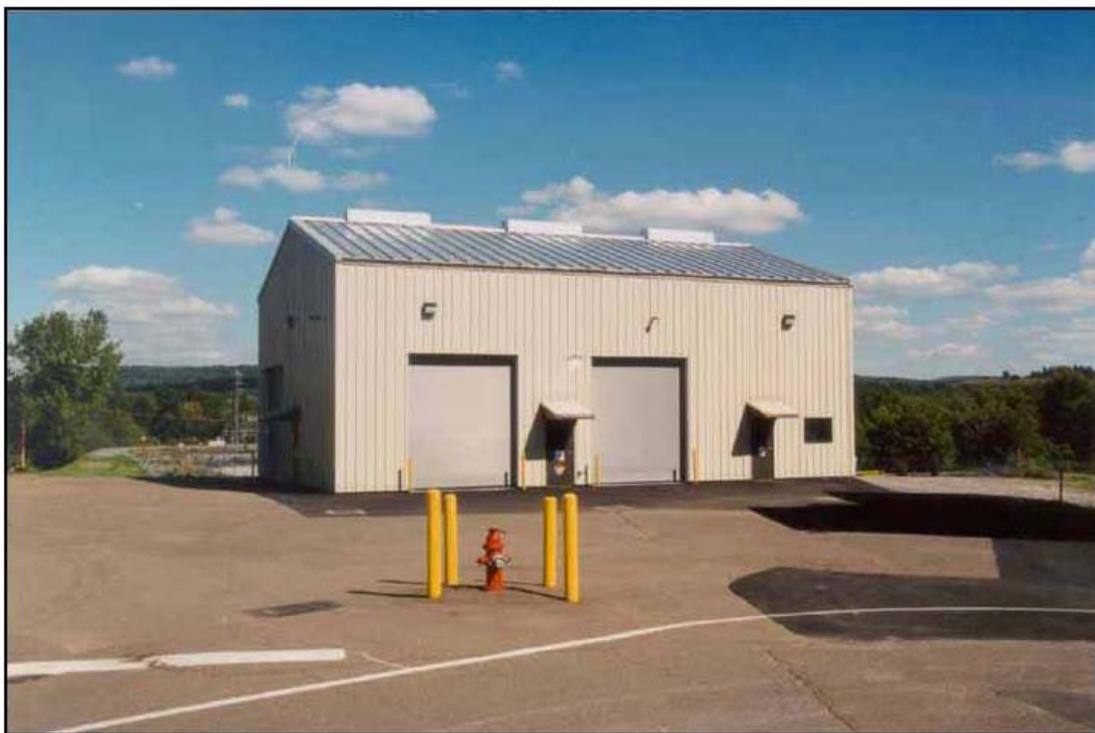
Figure 3-26. The LLW2 Building that Replaced the O2 Building

The LLW2 Building. Located southwest of Lagoon 4, this pre-engineered, single-story, metal-sided building rests on a concrete wall foundation, measuring 40 feet by 60 feet. The building houses two skid-mounted process equipment modules that are used to treat wastewater from WMA 1, WMA 3, and radiologically contaminated groundwater from the WMA 7 NDA Interceptor Trench and the north plateau groundwater plume. Figure 3-26 shows the building. The LLW2 Building was built in 1998 to replace the O2 Building, the original low-level wastewater treatment facility that was built by NFS in 1971.

The building is divided into three work areas and an office. The processing area contains the process modules (including ion exchangers, valves, piping, pumps, filters, instrumentation, and controllers), two surge tanks, and a sand filter. The packaging room contains a four feet by four feet by nine-feet-deep stainless steel lined catch basin. A portable ventilation unit located outside of the packaging area contains a high-efficiency particulate air (HEPA) filter and a short stack on the roof of the building.

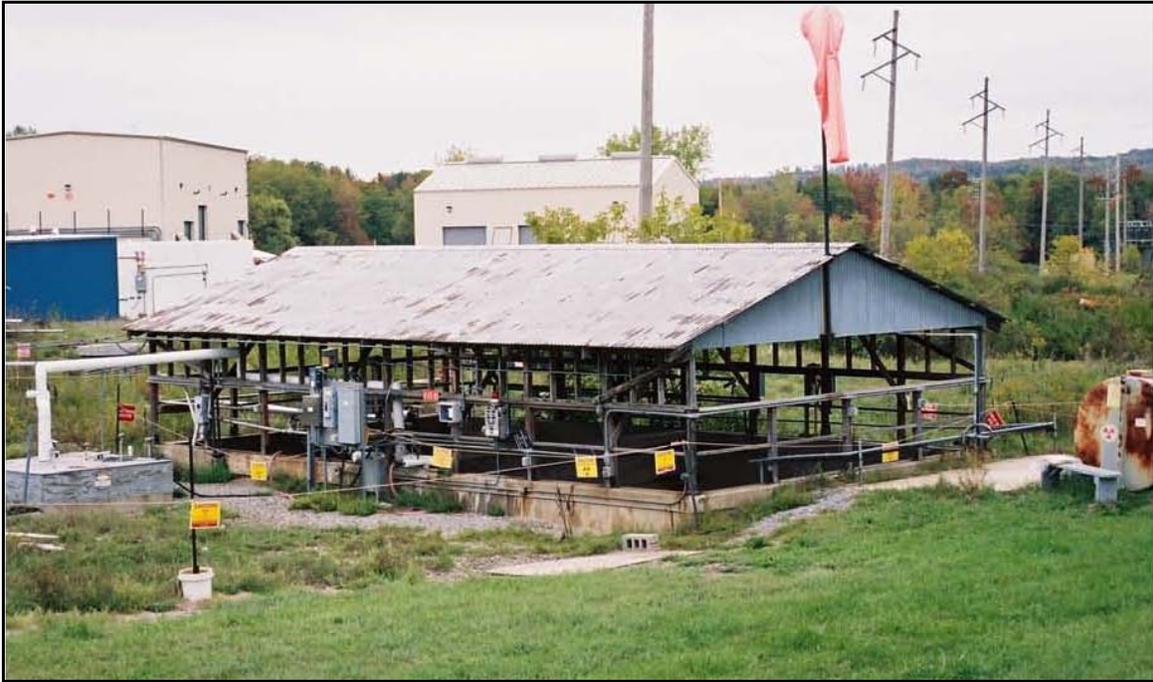
Figure 3-28. The New Interceptors. (These are twin stainless-steel lined concrete holding tanks.)

New Interceptors. The New Interceptors are twin open-top concrete storage tanks, each 22 feet by 20 feet by 11.5 feet deep, located below grade. The walls and floor are 14 inches thick, and are lined with stainless steel. The roof is steel. The New Interceptors were built in 1967 to replace the Old Interceptor, which had high levels of radioactivity (WVNSCO 1997). The New Interceptors are used to collect and sample wastewater before it is transferred to Lagoon 2.

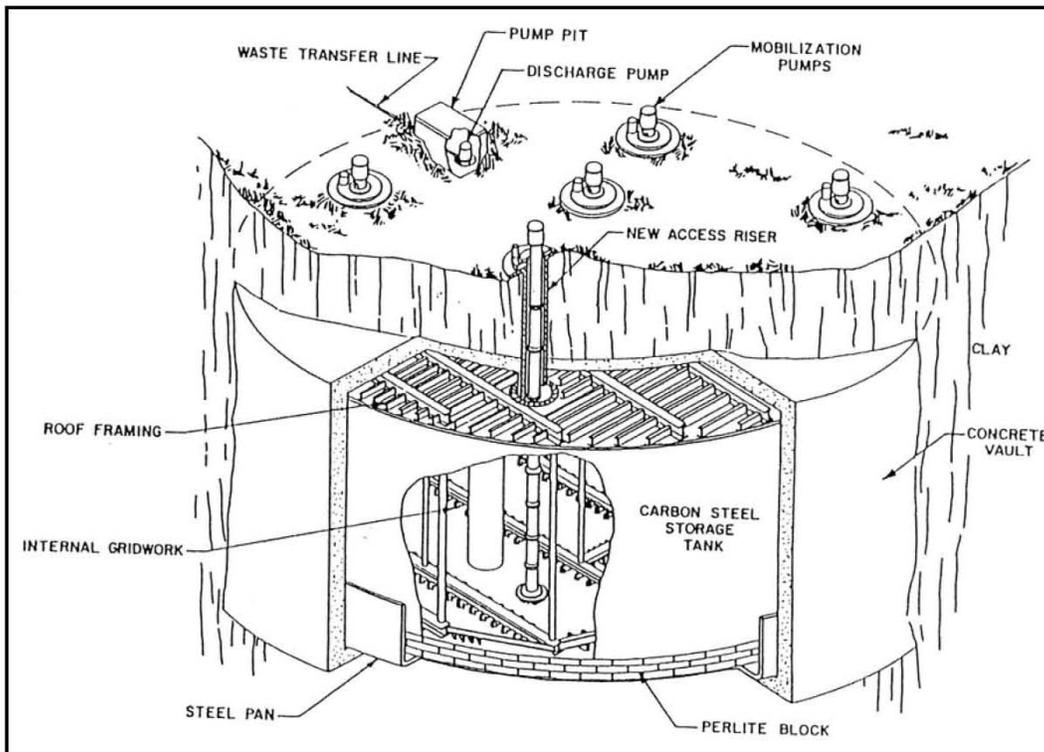
Figure 3-31. Cutaway View of 750-Gallon Underground Waste Tank

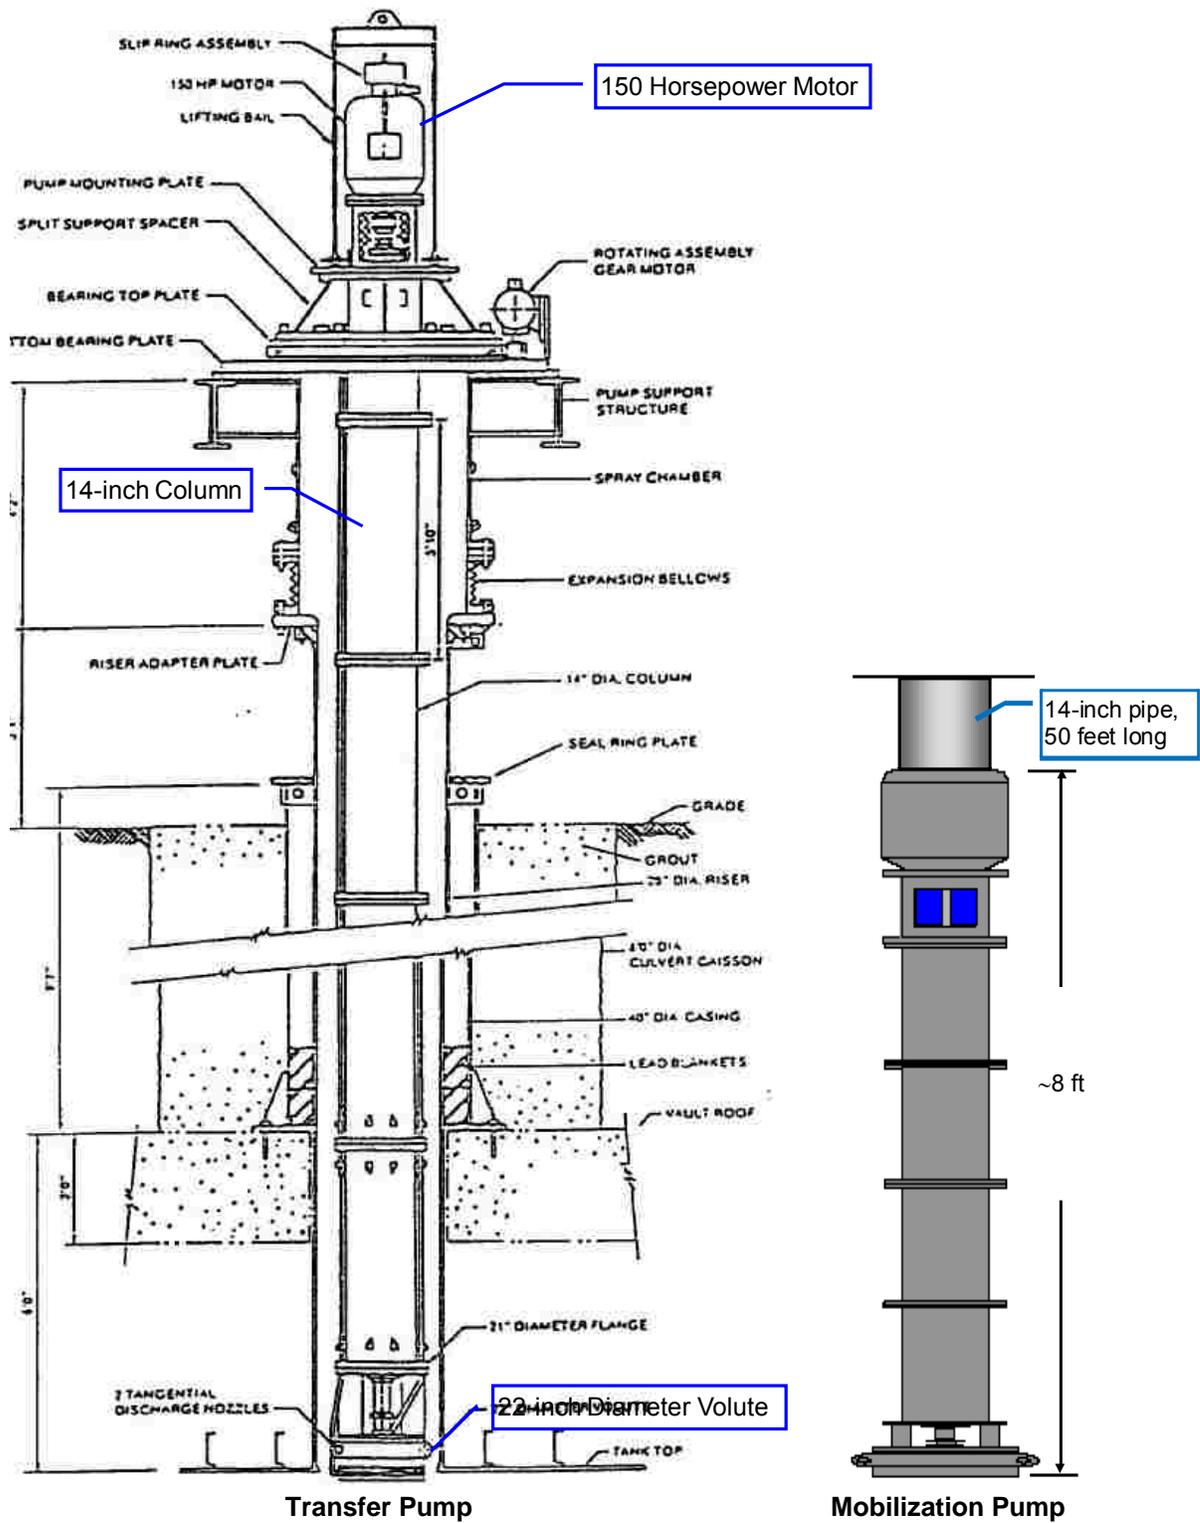
Figure 3-32. HLW Transfer and Mobilization Pumps

Tanks 8D-1 and 8D-2 each contain a single HLW transfer pump. Each centrifugal multi-stage turbine type pump is more than 55 feet long and is driven by a 150 horse power motor. Tanks 8D-1 and 8D-2 also contain a total of nine mobilization pumps. These pumps are approximately the same size as the HLW transfer pumps.

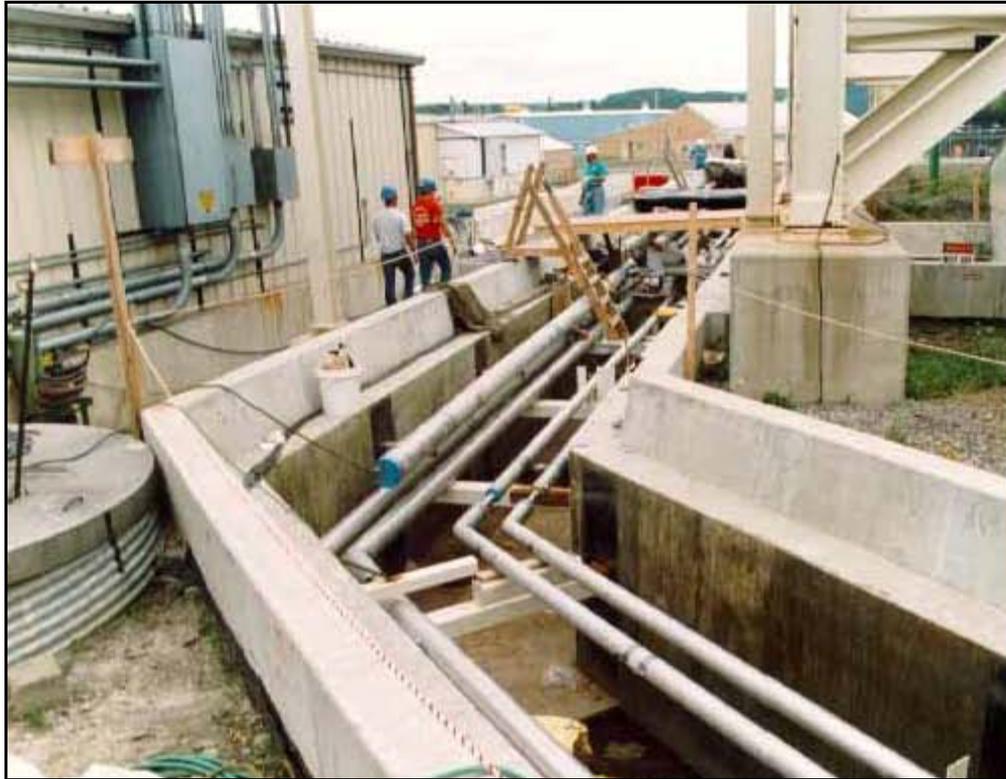
Figure 3-33. HLW Transfer Trench Under Construction

The trench was constructed with reinforced concrete walls and floors, with pre-cast concrete covers. Stainless steel-lined concrete pump pits that house the upper sections of HLW transfer pumps are located on top of each of the tank vaults. The walls and floors of the pump pits are reinforced concrete, with pre-cast concrete covers forming the roof. Figure 3-34 shows a typical pump pit.

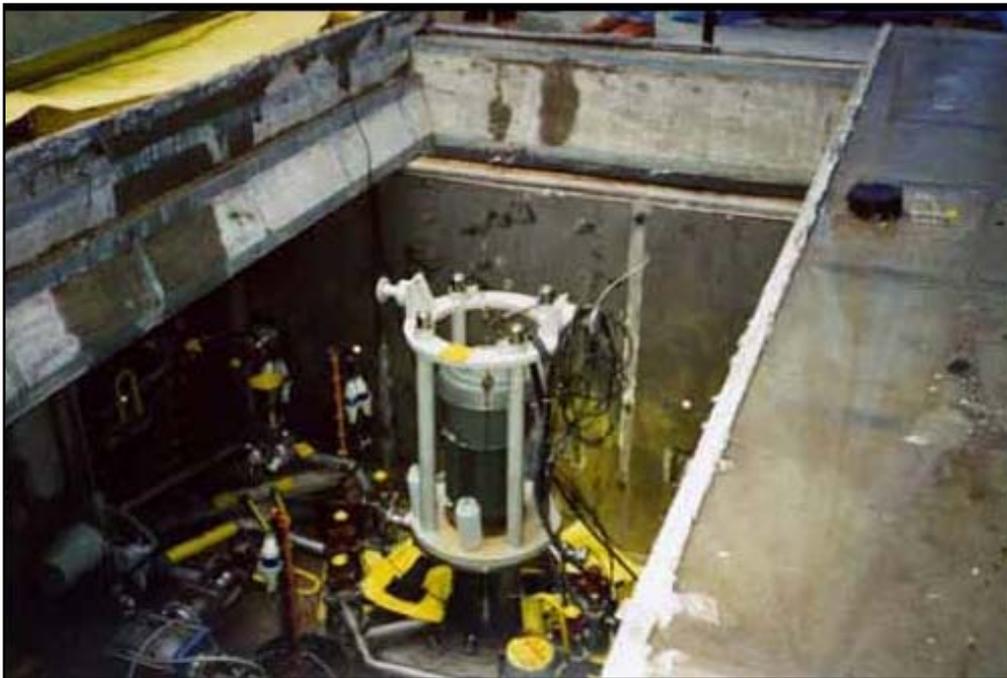
Figure 3-34. Typical HLW Pump Pit

There are six piping runs in the trench, two of which are unused spares, comprising approximately 3000 linear feet of double-walled stainless steel pipe.³ The trench also contains associated valves and jumpers. The pump pits each contain the upper part of the HLW transfer pump and flow monitoring equipment. Pump Pit 8Q-2 over Tank 8D-2 also contains grinding equipment used to size reduce zeolite.
