3.0 FACILITY DESCRIPTION

WVDP PHASE 1 DECOMMISSIONING PLAN

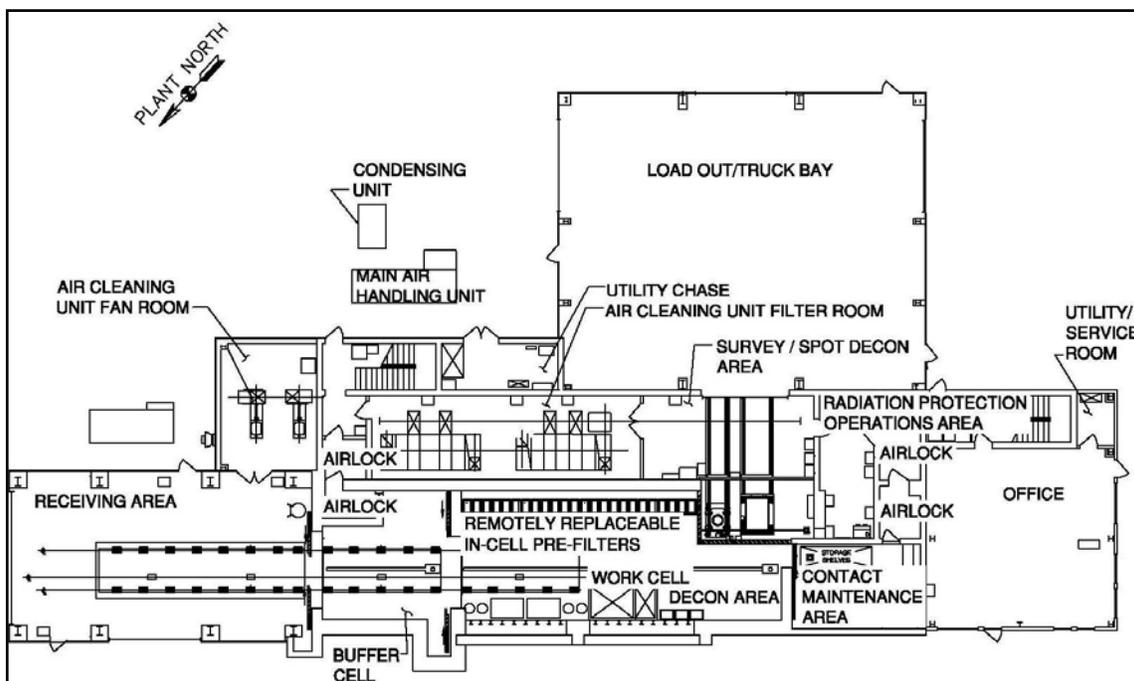
Figure 3-37. The Remote-Handled Waste Facility First Floor Layout.

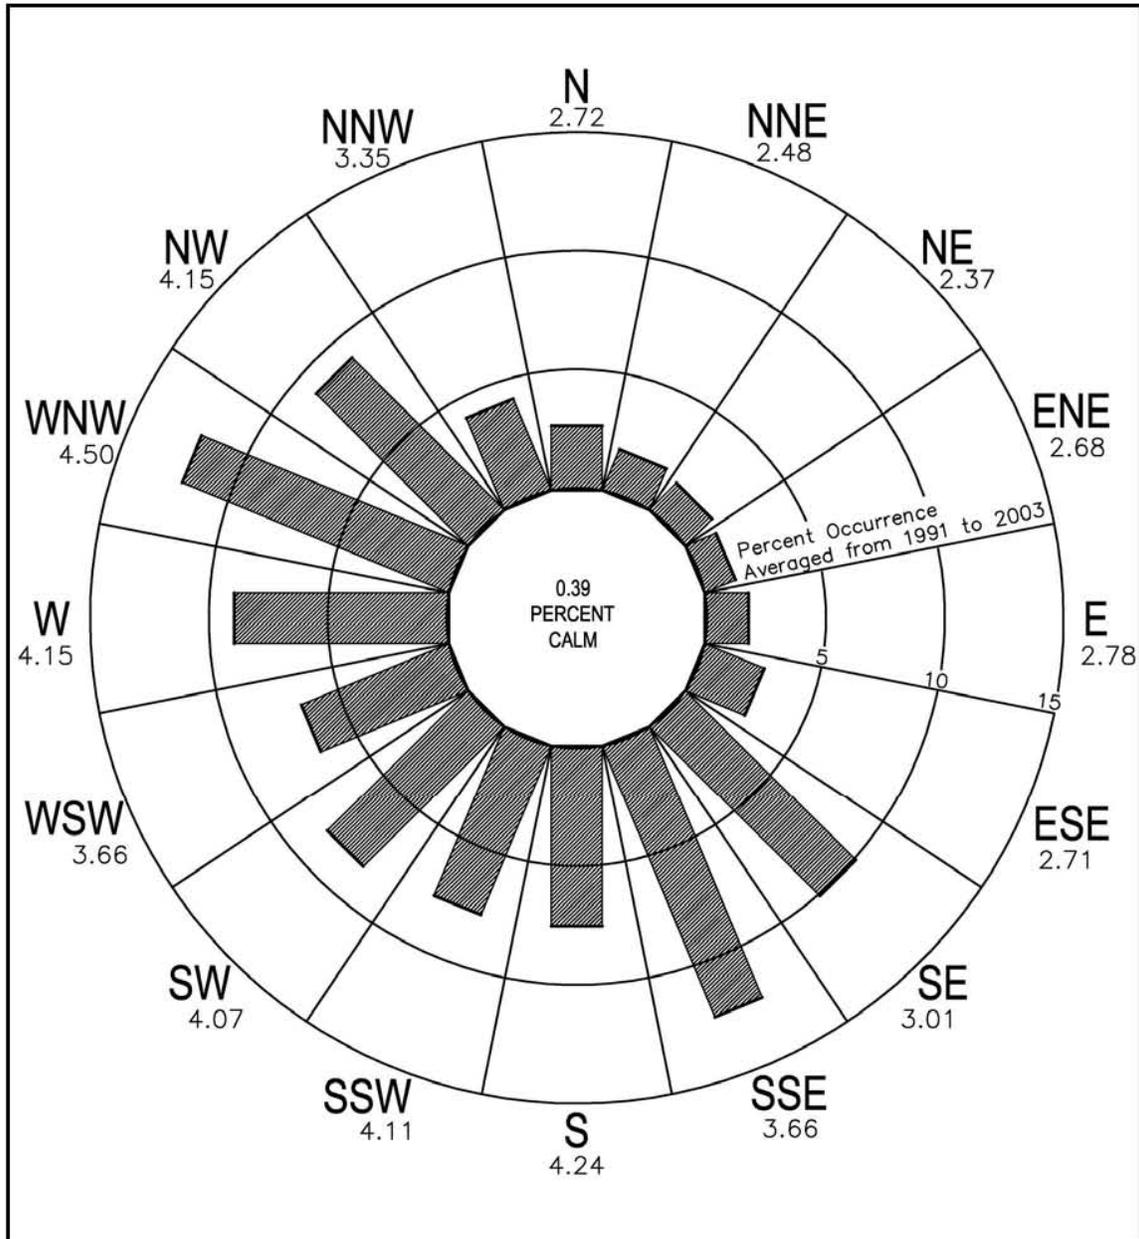
Figure 3-49. Wind Rose Diagram. (1991 – 2003 average head-wind direction and average wind speed in m/s)

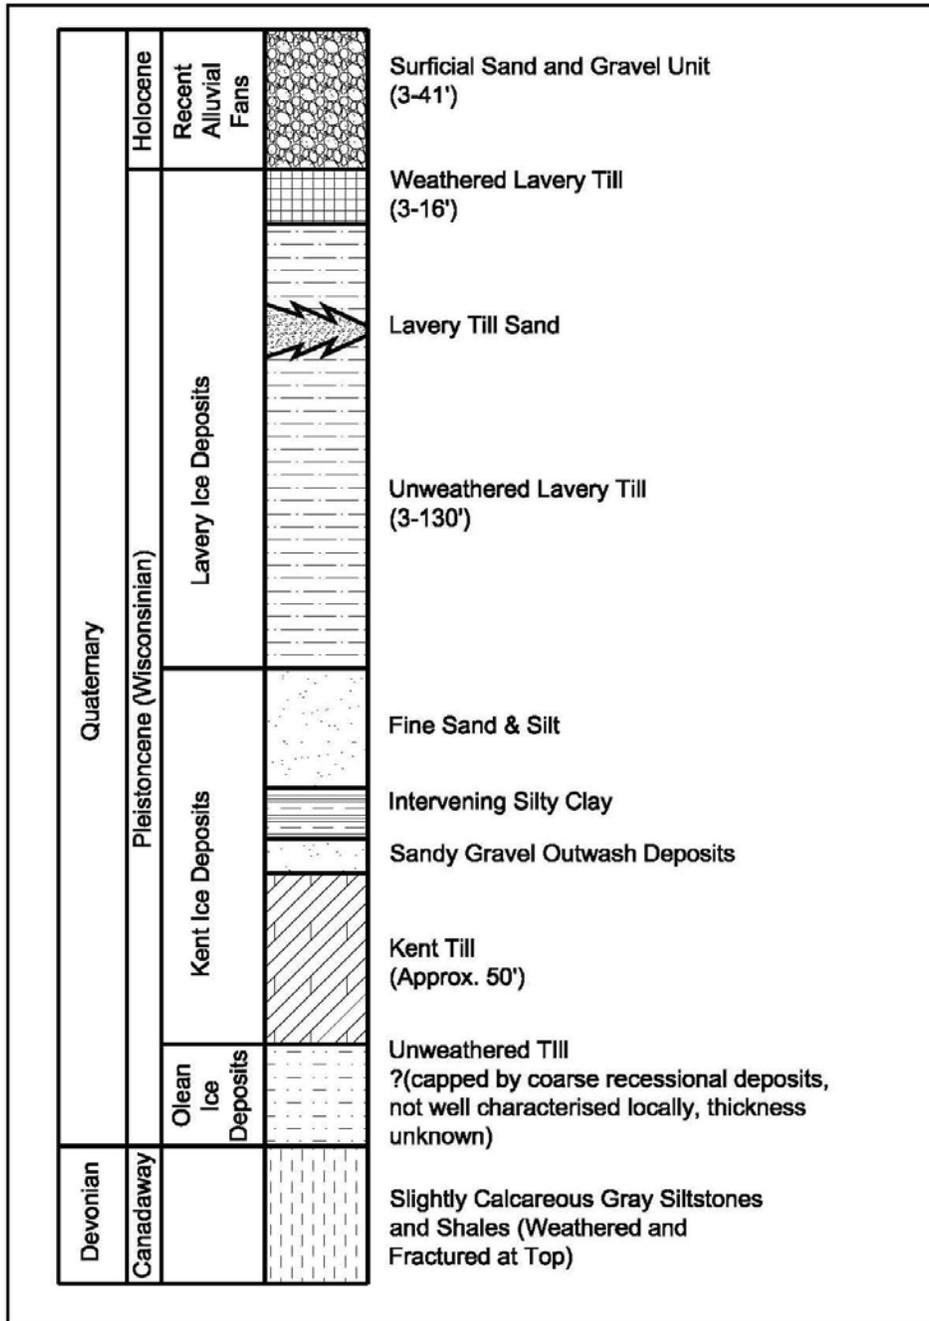
Figure 3-52. Bedrock and Glacial Stratigraphy of the WVDP

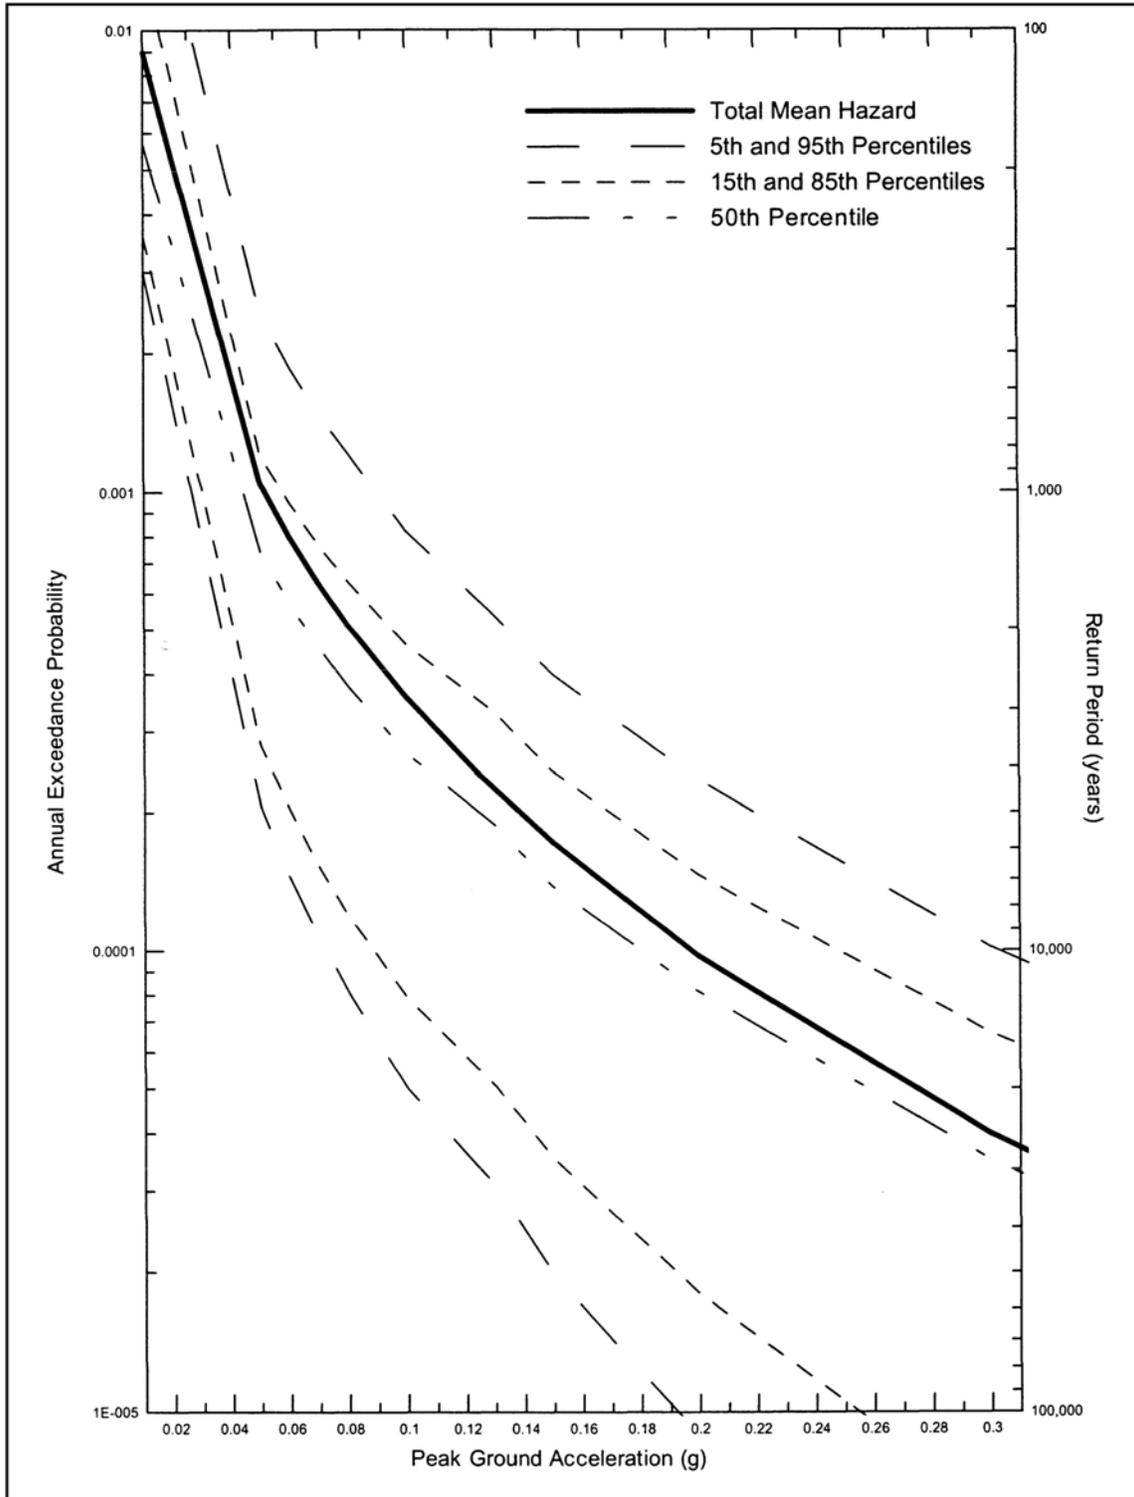
Figure 3-58. Seismic Hazard Curves for Peak Horizontal Acceleration

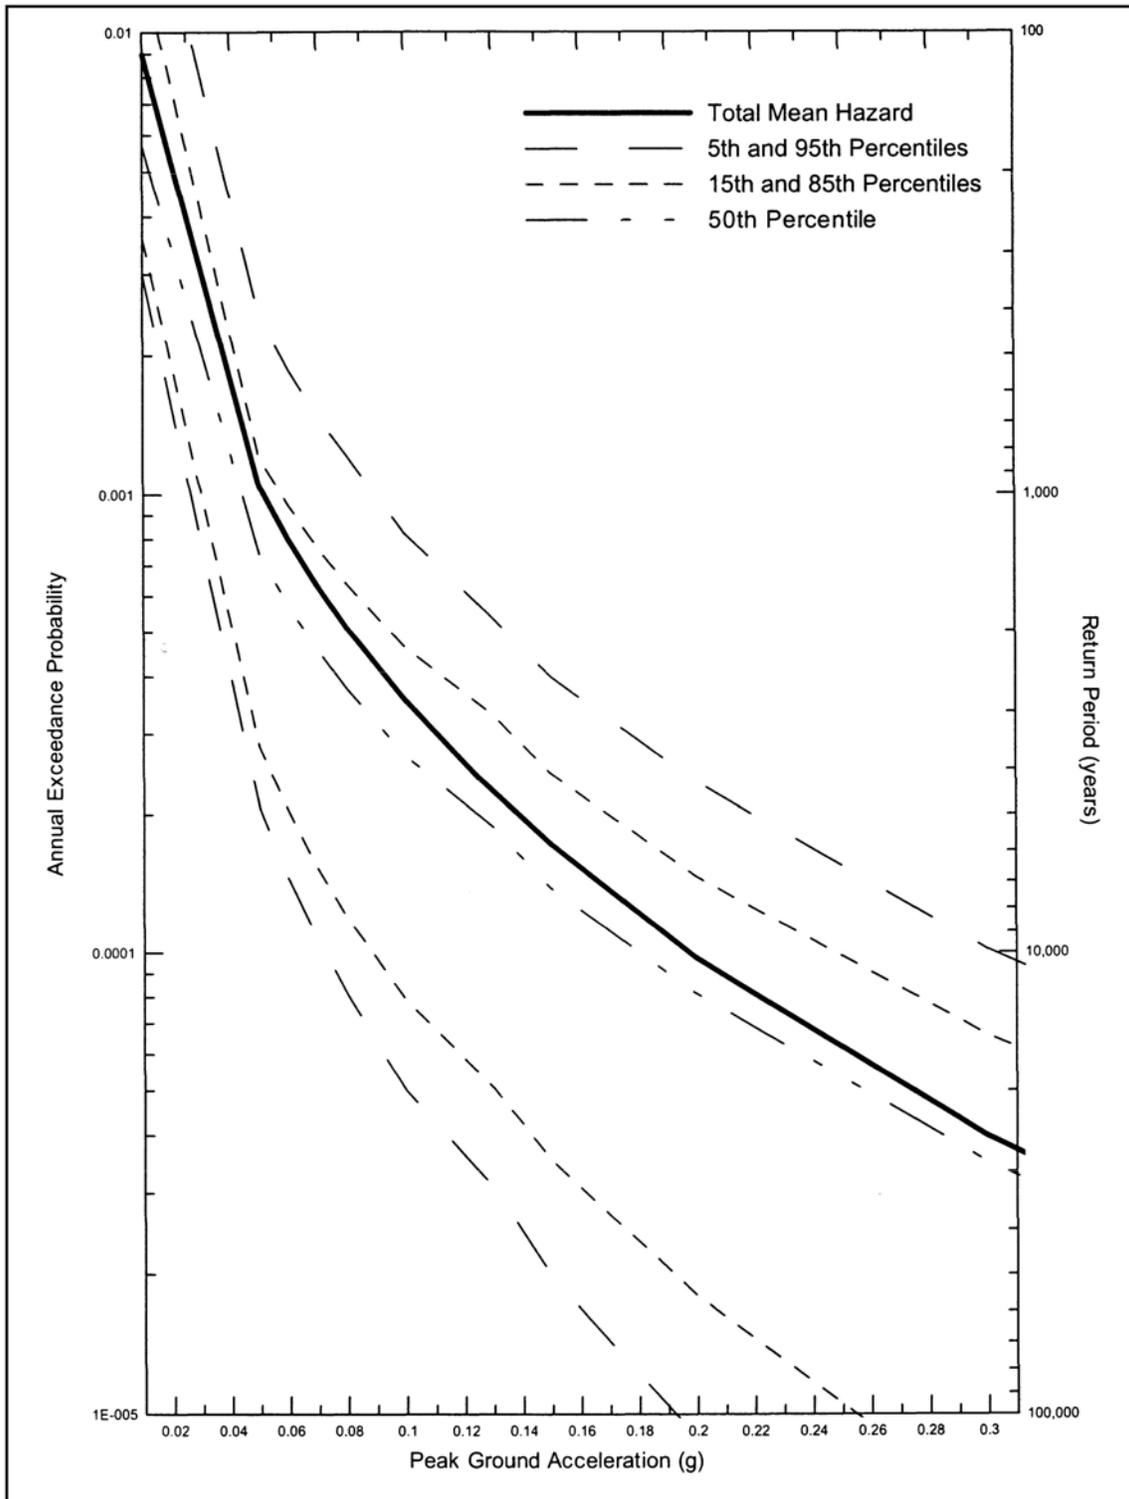
Figure 3-59. Seismic Hazard Curves for 1.0 Second Horizontal Spectral Acceleration

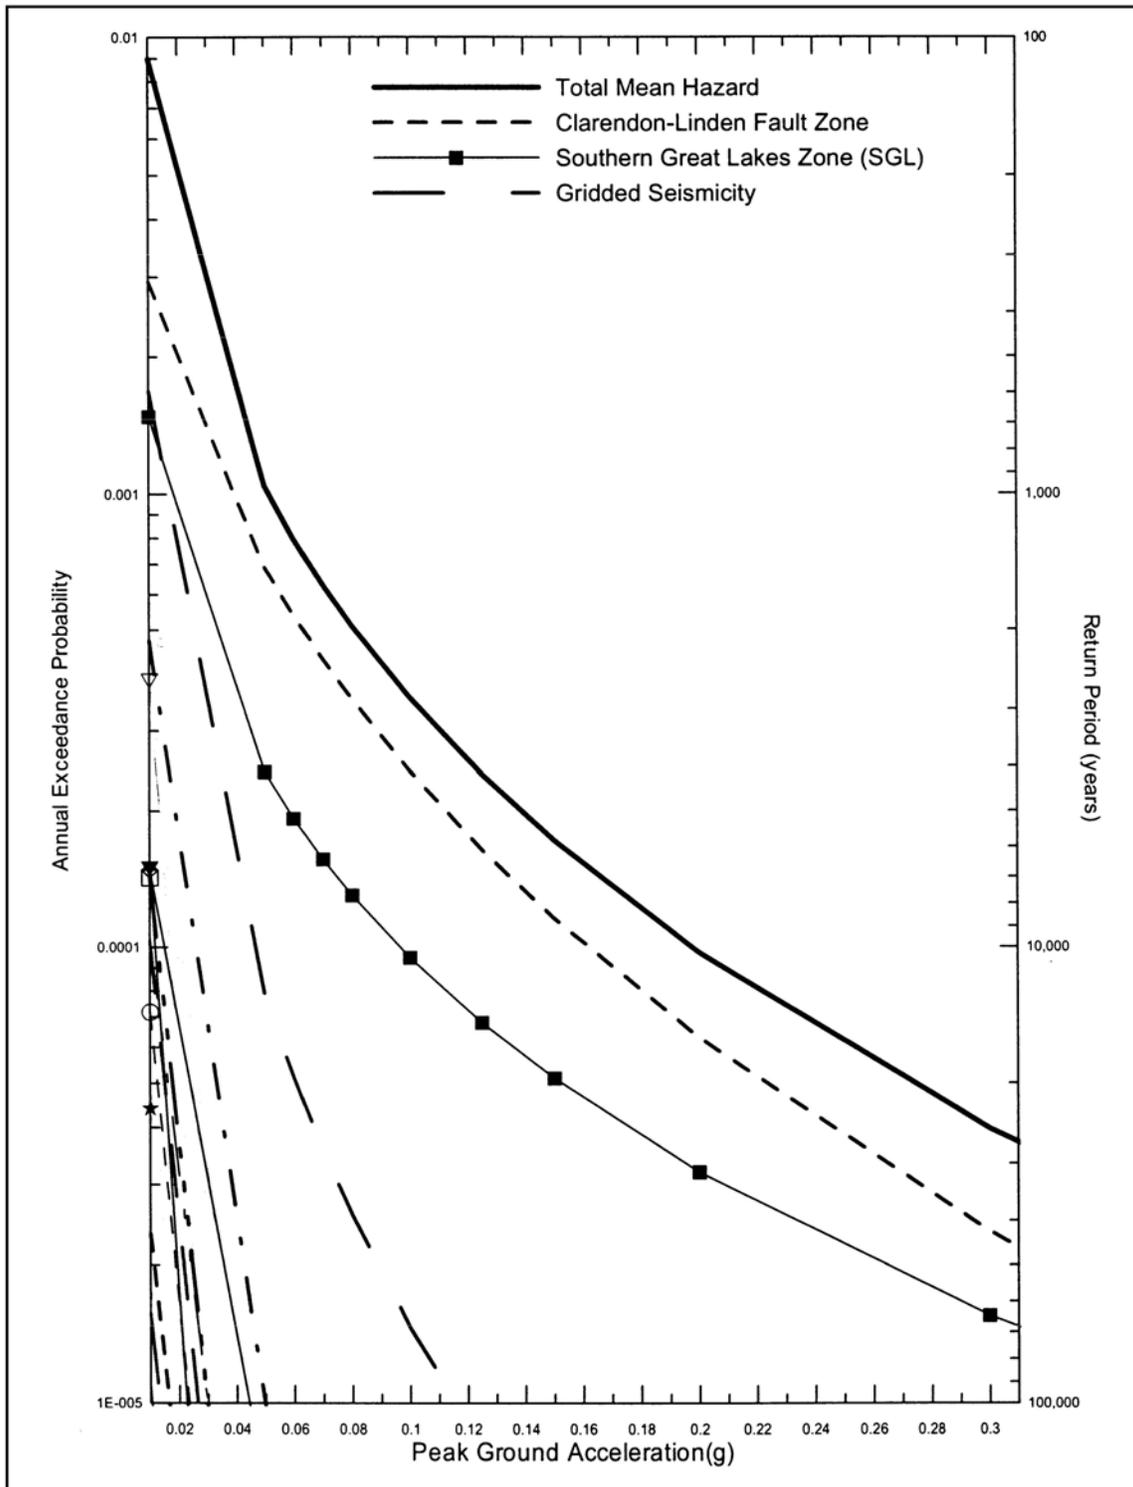
Figure 3-60. Seismic Source Contributions to Mean Peak Horizontal Acceleration Hazard

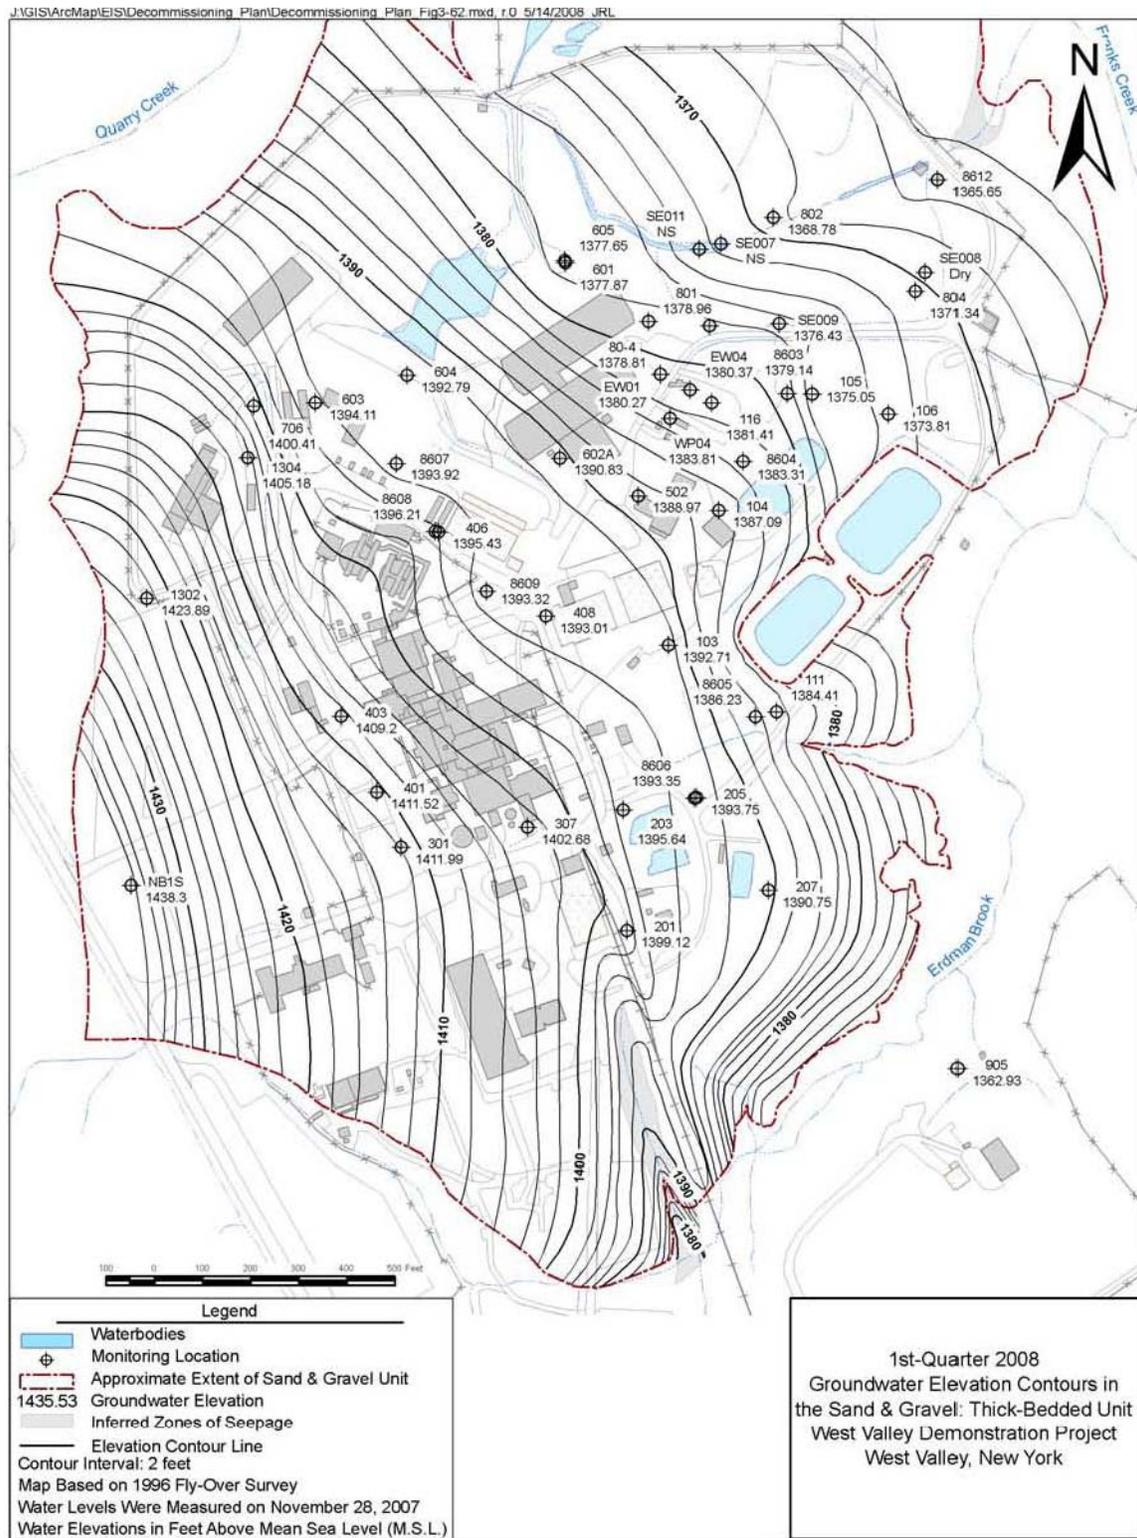
Figure 3-62. Groundwater Elevation Contours of the Sand and Gravel Unit, First Quarter 2008

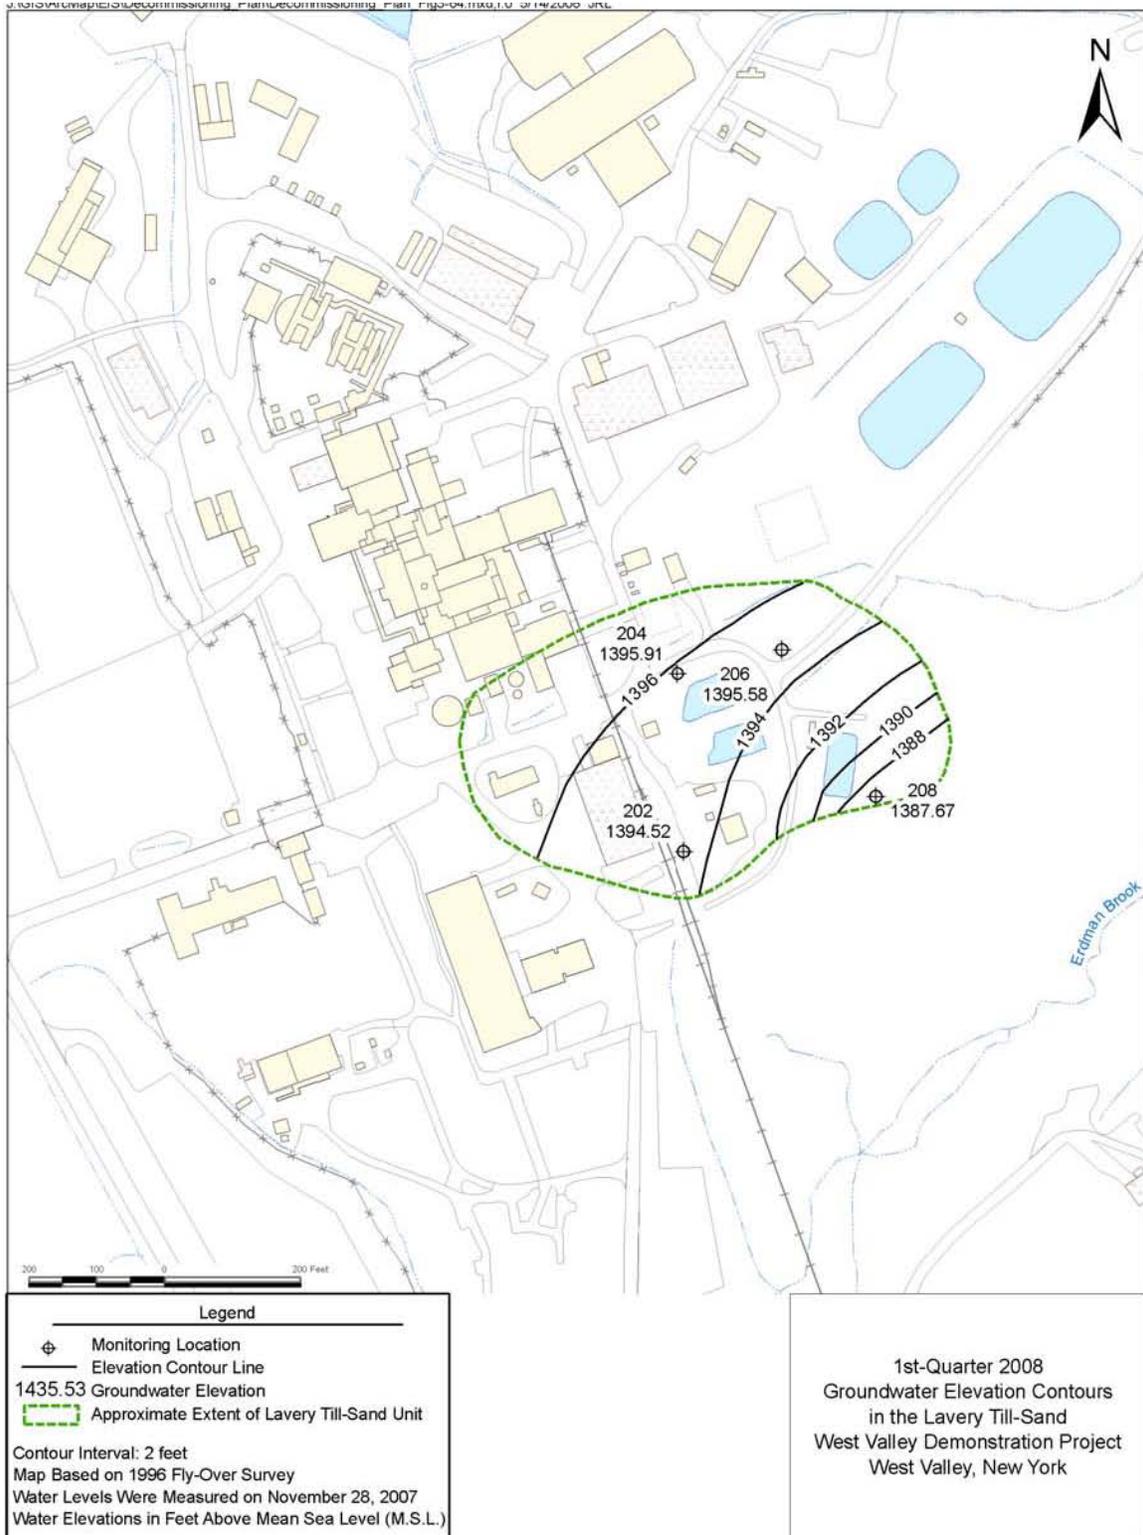
Figure 3-64. Groundwater Elevation Contours of the Lavery Till Sand, First Quarter 2008

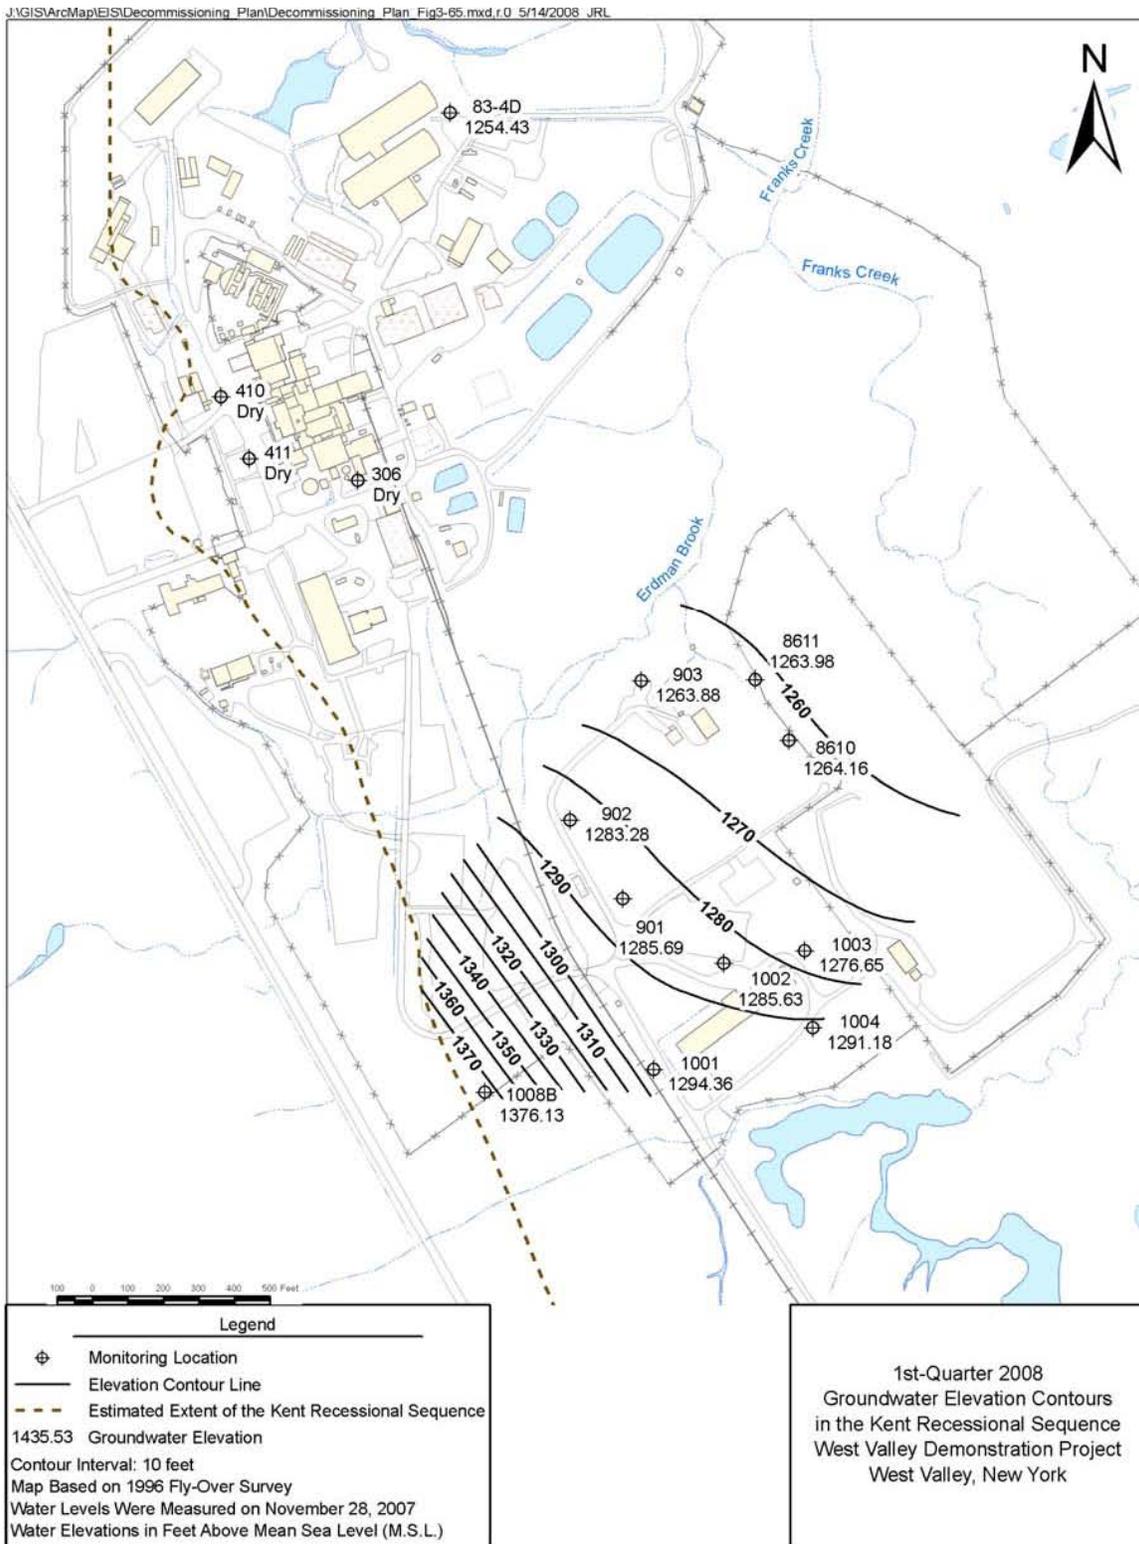
Figure 3-65. Groundwater Elevation Contours of the Kent Recessional Sequence, First Quarter 2008

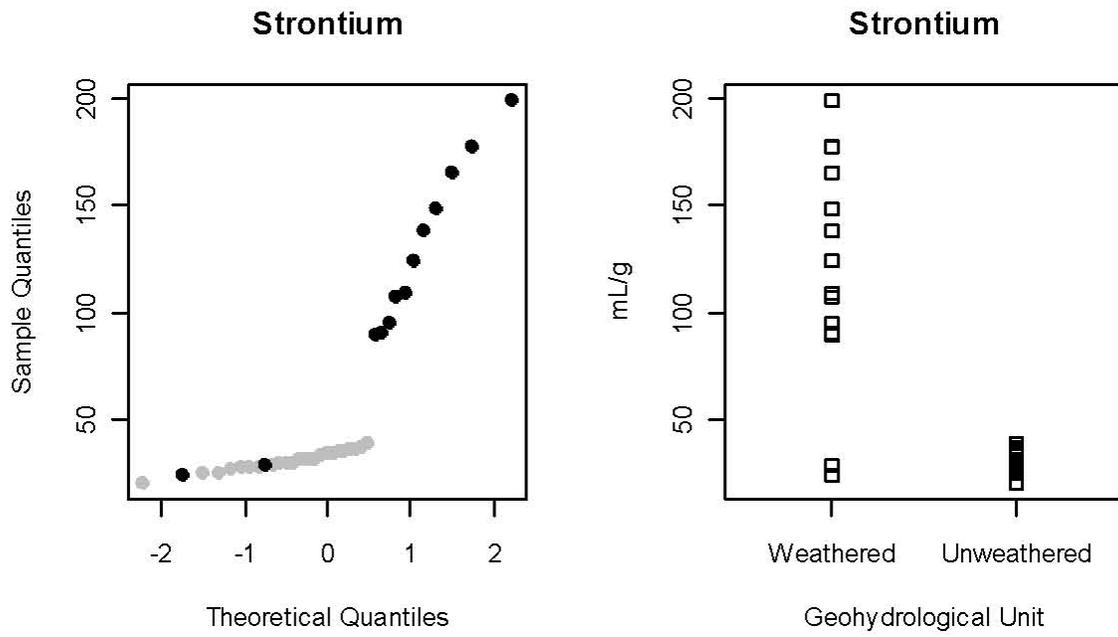
Figure 3-68. Vertical Distribution of Strontium K_d in the Weathered and Unweathered Tills (WVNSCO 1993a)
